# Report of the Expedition **GALLIPOLI 2011**

## WRECK 1 English patrol boat *Lundy*

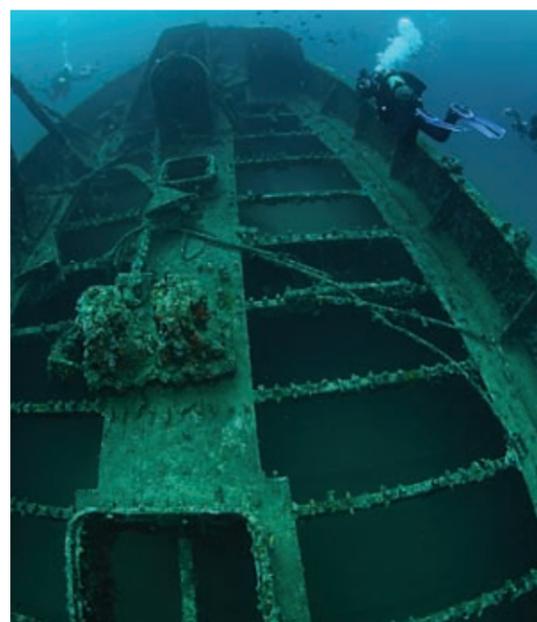
Fot. 4 *Lundy*, steel supports of the deck

We reached the coordinates of 40°17'806" N 26°12'970"E, at which the wreck of the vessel lies. After careful preparation of our equipment, we started the dive. We reached the bottom quite quickly because, at this point, the sea is only 28 meters deep. The team very quickly set about to the tasks assigned to them, as everyone knew exactly what they had to do. The ship lies evenly on her keel on a flat, sandy bottom. For being in a hostile environment for almost a century, she is very well preserved. All of her main parts are easily recognizable. Of course, there is nothing left of the wooden deck, but the steel supports, which it was attached to, show exactly where it was.

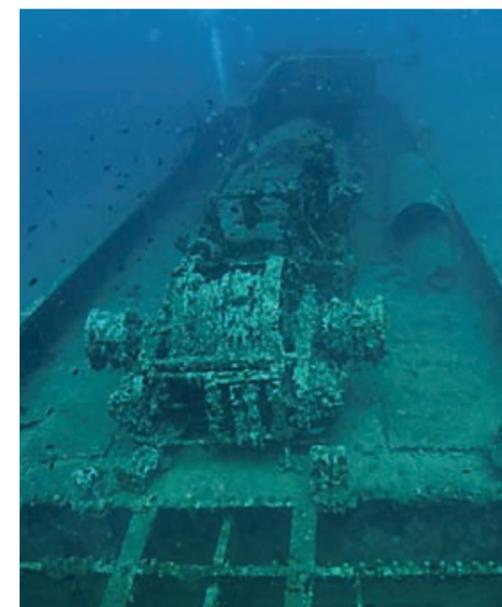
Fot. 5 *Lundy*, capstan

The bow hold is empty and relatively easy to penetrate because of the lack of deck. The capstan is virtually intact. The superstructure, which was originally constructed largely of wood, is not preserved. Only the heavily corroded metal parts remain, among which a door frame stands out on the portside.

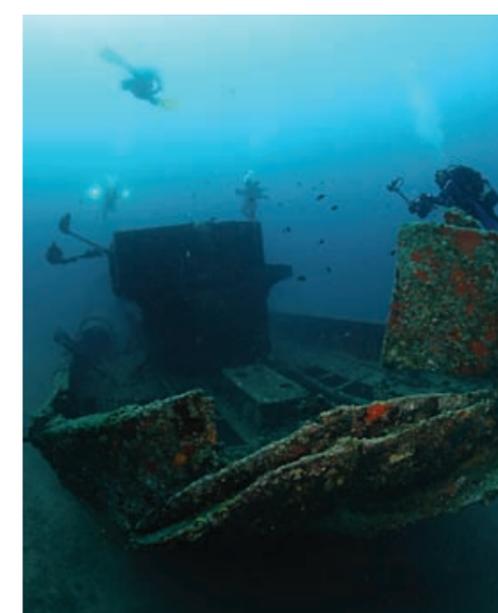
Fot. 8 *Lundy*, stern, point of collision

The most interesting part of the wreck, however, is undoubtedly the stern. It still bears very clear, recognizable signs of a collision. It can be seen that the deck's support structure is bent upwards; the metal stern plating is crushed and folded in a "harmonica." This shows that *Lundy* either struck, or was hit herself, in the stern, as records say, by the *HM Kalyan*.

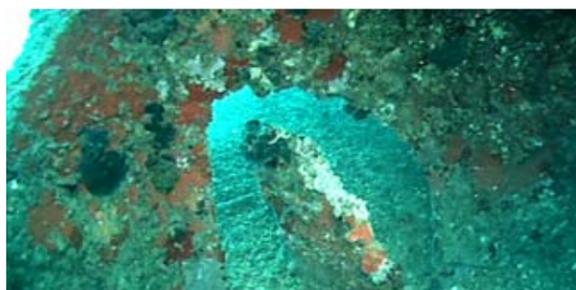
Fot. 9 Lundy, rudder and propeller

The rudder and the propeller are buried in the sand to the half of their height, but do not contain any signs of damage. This would mean that at the time of the collision, the vessels did not have too much speed. However, the damage sustained in the bending and the leaks in *Lundy's* stern proved to be sufficiently large to sink the ship.

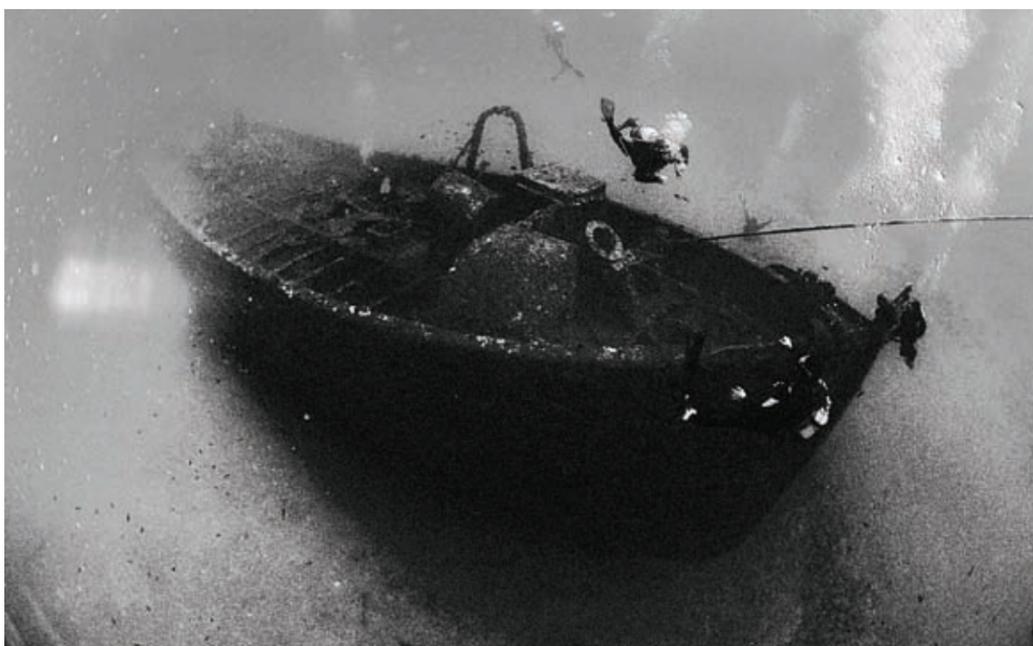
Fot.10 Lundy, graphics 2011

The measurements made by our team are as follows: length of the vessel: 33 meters, width: 6.3 meters, height of the sides above the sand: 2.2 meters. Comparing the current appearance of the wreck with the archival material, it is clear that *Lundy's* hull is intact (disregarding the deformation sustained by the collision). The degree of degradation of this wreck, taking into account the hostile environment it is in, is small. It is our opinion, that the wreck will retain its condition and form unchanged for many years.

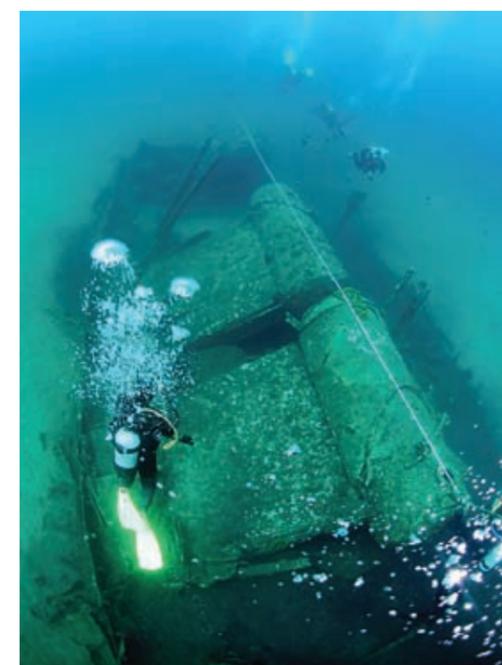
Fot. 11 Louis, amidship

We examined the wreck which lies at the position of 40°18'794" N, 26°13'562 "E in quite shallow waters at only 14 meters, on a sandy, flat bottom. It is, unfortunately, in bad condition. Its sides are almost completely destroyed. The visible part is only the bow, which is preserved only to the height of the engine deck. We suppose that the lower part of the hull, all the way to the keel, survived in very good condition, but confirmation of this is not possible, as the wreck is buried deep in the sand. The remains of the portside are already completely covered up. Their vague outlines can be seen. The remains of the starboard are sticking out of the sand to the height of 70 cm. The bow end of the ship looks as if it has been cut off (probably destroyed during the sinking, when it struck the sea bottom).

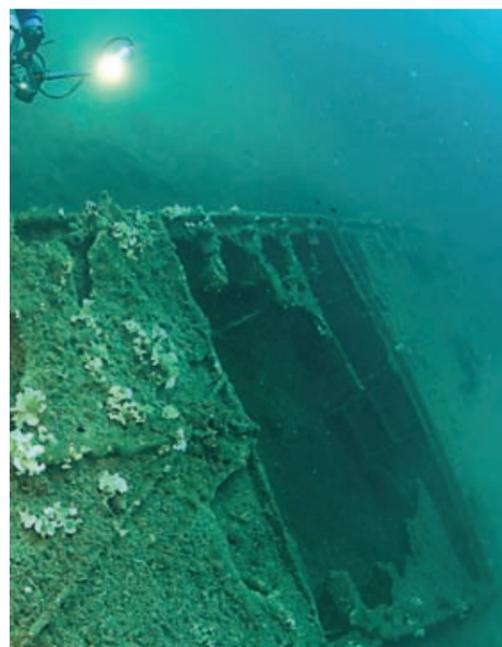
Fot. 14 Louis, steel ladder

Another visible part is the first bow compartment with a steel ladder leading inside, but it is also almost completely buried under the sand. Other preserved steel hull parts are heavily corroded. Amidships there are four round containers resembling steam boilers, and considering the overall bad state of the unit, they are in relatively good condition. Although they are heavily overgrown with marine organisms, the details of their design can be easily recognized.

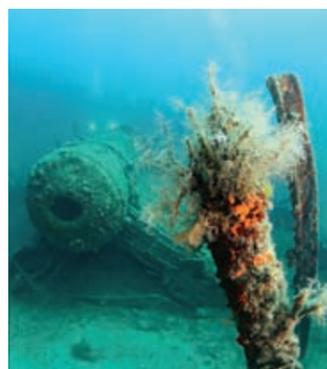
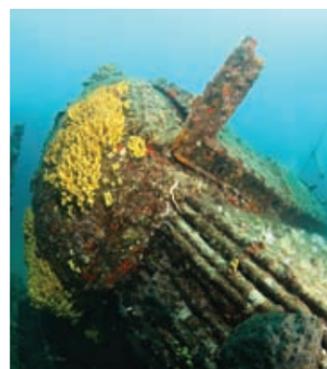
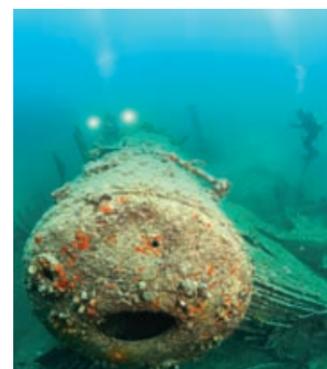
Fot.15, 16, 17 Louis, boilers

The rows of tubes attached to a cylindrical tank, running on both sides at an angle of 45 degrees and forming a characteristic cross section of an upside-down letter "V," can also be easily seen. Considering the bad condition of the wreck, these devices make an impression as if being out of place. There is no trace of the vessel's stern.

The cylinders with rows of tubes are the Yarrow type steam boilers, which were used in the navies of many countries of the world during this period. Our visual materials seem to be enough evidence to identify the *HMS Louis*. Unfortunately, the results of our work also show that soon the only remains visible will be the steam boilers, and the remainder of the ship will vanish completely. Already, the large degree of destruction of the wreck makes it impossible to precisely state the ultimate cause of the sinking of this interesting ship. We must, therefore, accept the official report of the Royal Navy.

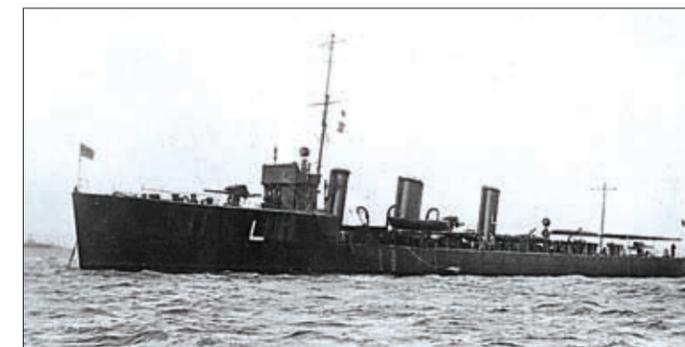
Fot. 18 Louis, archive photo

The analysis of the sources and archives relating to the sunken ships in the area shows that it is more likely that the Australians from the *Beneath Gallipoli* project are correct in respect to this ship, rather than our Turkish guides. The Australians identified this ship as the British "Laforey" class destroyer *HMS Louis*. The ship had a deep load displacement of 1300 tons and was lost on October 31, 1915. This is contradictory to the desalination ship theory proposed by the local Turkish guides. According to The National Archives<sup>4</sup>, the ship was anchored near the shore of the Sulva Bay. During the early hours of the morning a south-west storm-strength wind picked up. The ship pulled on the anchor and ran aground, where it was quickly abandoned by the crew with no loss of life. For several weeks, the vessel was a perfect target for the Turkish field artillery and was methodically shot, which partially explains the bad condition of the wreck. Our findings also suggest that we are dealing with the above-mentioned ship.

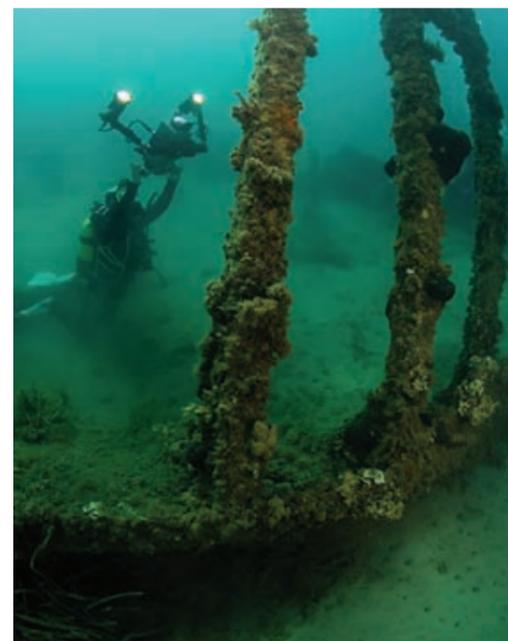
Fot. 21 *Milo*, hull

The status of this ship is, unfortunately, tragic. Storms and scrap collectors have done their part over the years. On the sandy, shallow bottom (at this point, the depth does not exceed 10 meters) lay the remains of *Milo*, which is virtually only the bottom part of the hull. We measured the sides being just 1.8 meters at the highest outcrop and the average is significantly lower. The bow and the stern no longer exist. The best-if it can even be defined as that- preserved part is the amidships, where the keel with framing is still beautifully visible. Inside the wreck (although at its current state, it is actually also outside) there is a substantial amount of coal, which is quite surprising because it shows that this cargo was wasted by the Allies<sup>6</sup>. Coal was, after all, quite scarce in war conditions and should have been moved to another ship before the sinking of *Milo*.

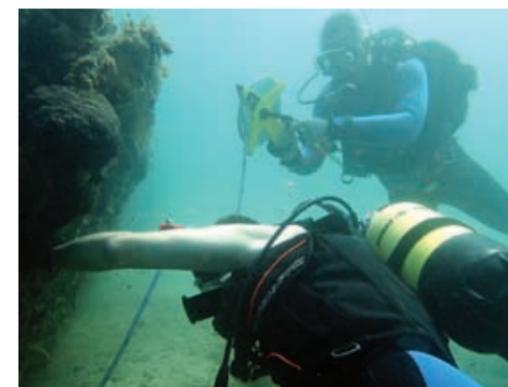
Fot. 22 *Milo*, measurements

it is very exposed to the forces of nature. The storms and the sand will soon complete their slow work of destruction, and besides the tons of coal lying on the seabed, nothing from the ship will remain there much longer. The current length of *Milo* is 17.7 meter and the width is 9.3 meters. According to shipyard dimensions, she was once 73.3 meters long, so more than 55 meters of the vessel is missing. The height of the sides was originally 4.8 meter. If we compare this to a small, 1.8 meter piece of hull, which has been preserved to this day, we can immediately see the huge degree of degradation of the vessel.

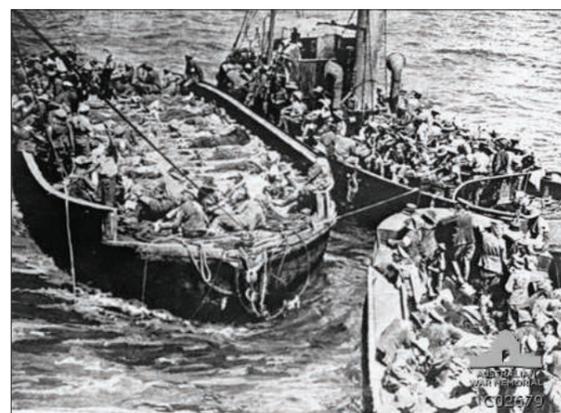
Fot. 25 Barge, archive photo

The last wreck, which we were able to explore on the Aegean Sea, was a landing craft, which was used mainly to transport the wounded from the mainland to the hospital ships (confirmed by numerous archival photographs). This vessel was located by sonar in 2010 by the members of the *Beneath Gallipoli* project, but in their report they do not mention documenting her or actually diving on the wreck. Our examination, supported by extensive photographic and film material, as well as this report, is the only existing documentation describing this unit after her demise. The vessel lies at the coordinates of 40°17'140"N, 26°13'286"E, south-west from Cape Küçük Kemikli (also called Nibrunesi Point).

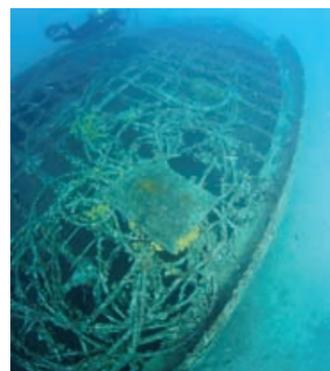
Fot. 26 Barge, coils of rope

The object of our interest lies precisely at 29.2 meters on a flat, sandy bottom. It is very well preserved. Naturally, the wooden deck is gone, but its thick metal frame is nearly flawless to this day. On the deck, in the stern and the mid sections, there are coils of thick

ropes, probably used to tow the barge, by some other vessel (maybe a destroyer). The stern and the rudder are intact. Inside, that is under the deck, the very well preserved hull can be seen and the distinct framing that supports can be noticed. Once inside, two holes from the shell that send the unit underneath the Aegean Sea surface can also be seen. The holes are clearly visible because of the contrast between the dark grey hull and the blue background of the sea, which seems to be seeping light into the interior. The entry point is on the portside, approximately five to six meters from the stern. It has a diameter of about 10 cm. The exit hole of the same size is visible on the starboard in the middle of the ship. Looking

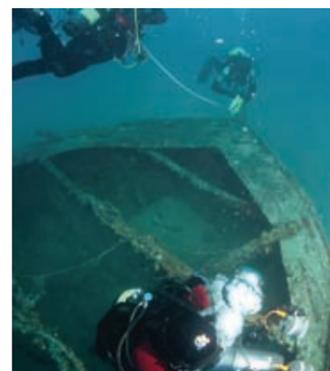
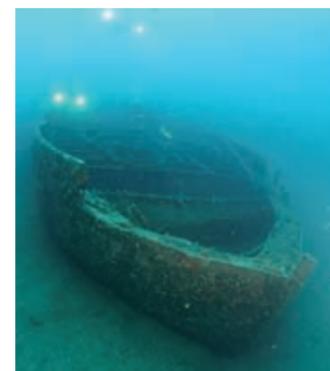
Fot. 27 Barge, stern

Fot. 28 Barge, sheathing, stern

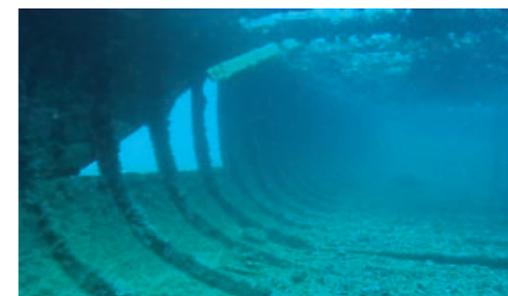
Fot. 29 Barge, gap, starboard

a rupture in the shape of a right triangle. It is exactly nine meters from the stern, its length is 3.1 meters and its height is 0.8 meters. The hull plating is bent outwards. This damage has been, most likely, done either by fishing net or an anchor just after the war, when the metal plating was still elastic and the hull was not corroded. There is no doubt that the cause of the ship's sinking was artillery fire. Unfortunately, it is very difficult to find source materials on lost smaller boats, barges, and landing vessels, as well as the casualties involved with the sinking. The barge is aligned with its stern to the shore, so we cannot exclude the scenario where the wounded soldiers that were transported died together with the ship. However, no human remains were found in or around the wreck, so the fate of the passengers will remain a mystery.

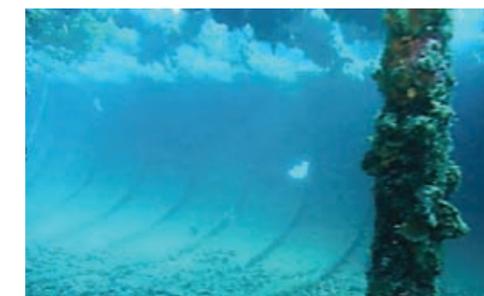
Fot. 30 Barge, hole from the shell, portside

at the mutual position of the two holes, we can conclude, with an almost certainty, that it was a single hit. The shell penetrated the hull and went out on the other side without exploding. It is also likely because the hull is quite thin. Close to the exit hole on the starboard there is

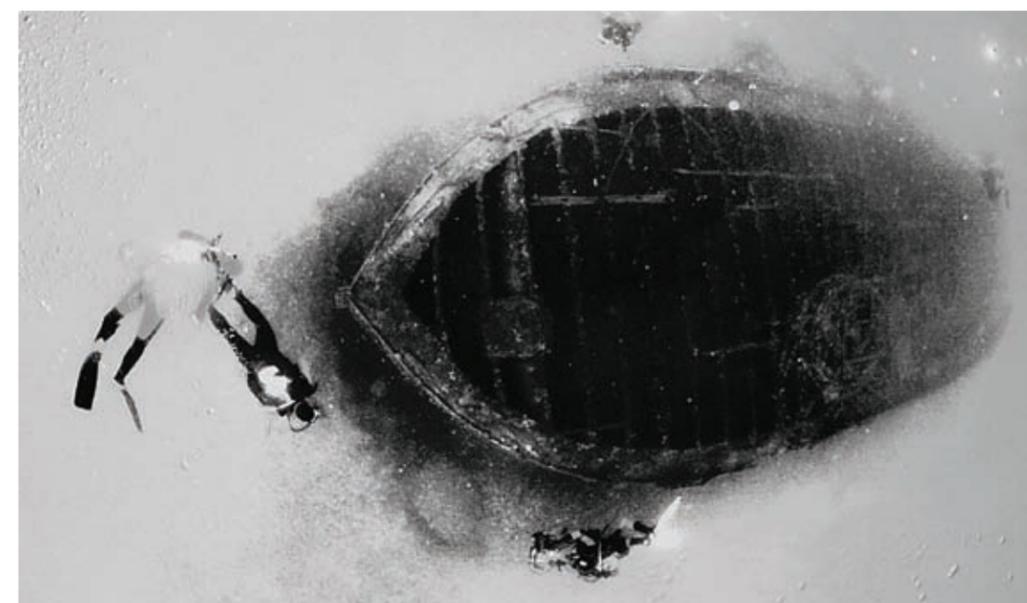
Fot. 31 Barge, graphics 2011

The barge we explored as the first expedition is a very interesting and well preserved wreck. It is our opinion that the degradation level is low and that one can count on the wreck to remain in good condition. The dimensions of the barge are: length 17.5 meters, width 6.2 meters height of the sides 2.8 meters, the framing is set in equal 90 cm intervals.

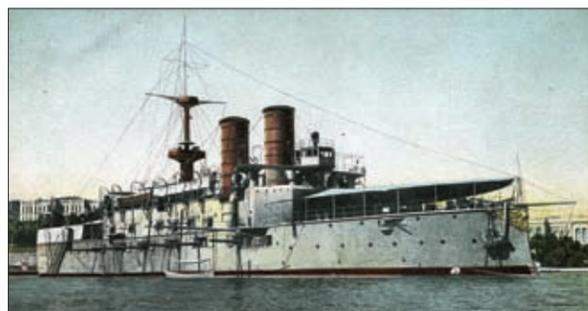
Fot. 32 *Mesudiye*, archive photo

The first wreck that we explored in the Dardanelle Strait was the Turkish battleship, *Mesudiye*, lying on the position of 40°07'287"N 26°23'904"E at a depth of 12 meters in the Sarısığlar Bay, near the Asiatic coast. At the outbreak of World War I, the battleship was already over 40-years-old; it returned to serve in the Ottoman navy in 1903 after a major upgrade, which took place in Italy. Although the "new" *Mesudiye*, at first glance, did not resemble itself before the "lifting", its construction was very outdated already in 1914. To make matters worse, just before the outbreak of World War I, both of her main artillery units (234 mm L/40) were disassembled and transported to Britain, where they were to be repaired. These guns failed to return to the ship, as the Ottoman Empire and Britain fought on opposite sides of the front in the Great War. Being so outdated and partially disarmed, the battleship could not have been used in open battle on the high seas. In September 1914, it was decided to send her to the Dardanelles, where as a floating battery, she had to shoot from the Sarısığlar Bay to the entrance of the Strait by indirect fire over Cape Kepez. She had to use her medium caliber artillery, which was a total of 12 150 mm L/45 guns (6 on each side). On December 13, 1914, *Mesudiye* fell victim to a torpedo attack by the British submarine *B 11*. After receiving two hits (one to each the bow and the stern) without possessing watertight bulkheads and without being under steam, the battleship sunk very quickly. Shallow bays at the site of anchoring caused that the ship tilted about 120° and rested at the bottom of the sea, so that the starboard and a large part of the hull (almost to the keel) protrude above the surface. Shortly after the wreck sunk, the majority of the crew (54 officers and 573 sailors) were rescued without major problems. The hull still entrapped 15 officers and 28 sailors. After a 36 hour rescue operation, it was managed to rescue only eight of them. Sometime after the sinking, some artillery weapons, ammunition and equipment, which could be used on land, were recovered from the *Mesudiye* wreck<sup>7</sup>. The hull of the battleship protruded from the water until the 60's of the twentieth century, when it was, unfortunately, shared by the fate of others, some parts remaining on the surface of the sea, as well as artillery armament of the Dardanelles forts – the decision of the Turkish government fighting with the crisis at the time was to cut her to scraps.

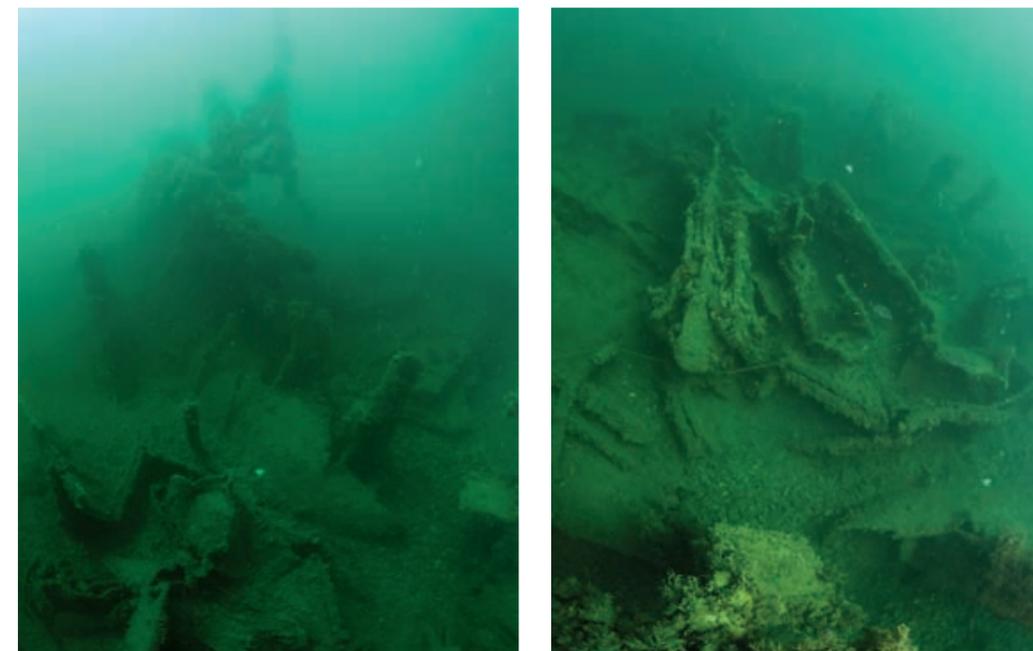
Fot. 33, 34 *Mesudiye*, junkyard

Today the state of the wreck is worse than tragic. Underwater, essentially remain only fragments, which have not been able to be reached or which could not be extracted during a planned devastation of the vessel. During underwater exploration, when more than five meters of visibility was not our ally, we were not even able to determine which part of the ship we could currently find ourselves on. The wreck is virtually one big junkyard, which largely consists of cut pieces of sheet metal burners and elements of the hull structure.

We are not able to present the reconstruction of the current state of preservation because it is not possible to identify any part or section of the ship. In some places, only larger pieces of bent and twisted metal plating, connected with one another on the rivets, are visible.

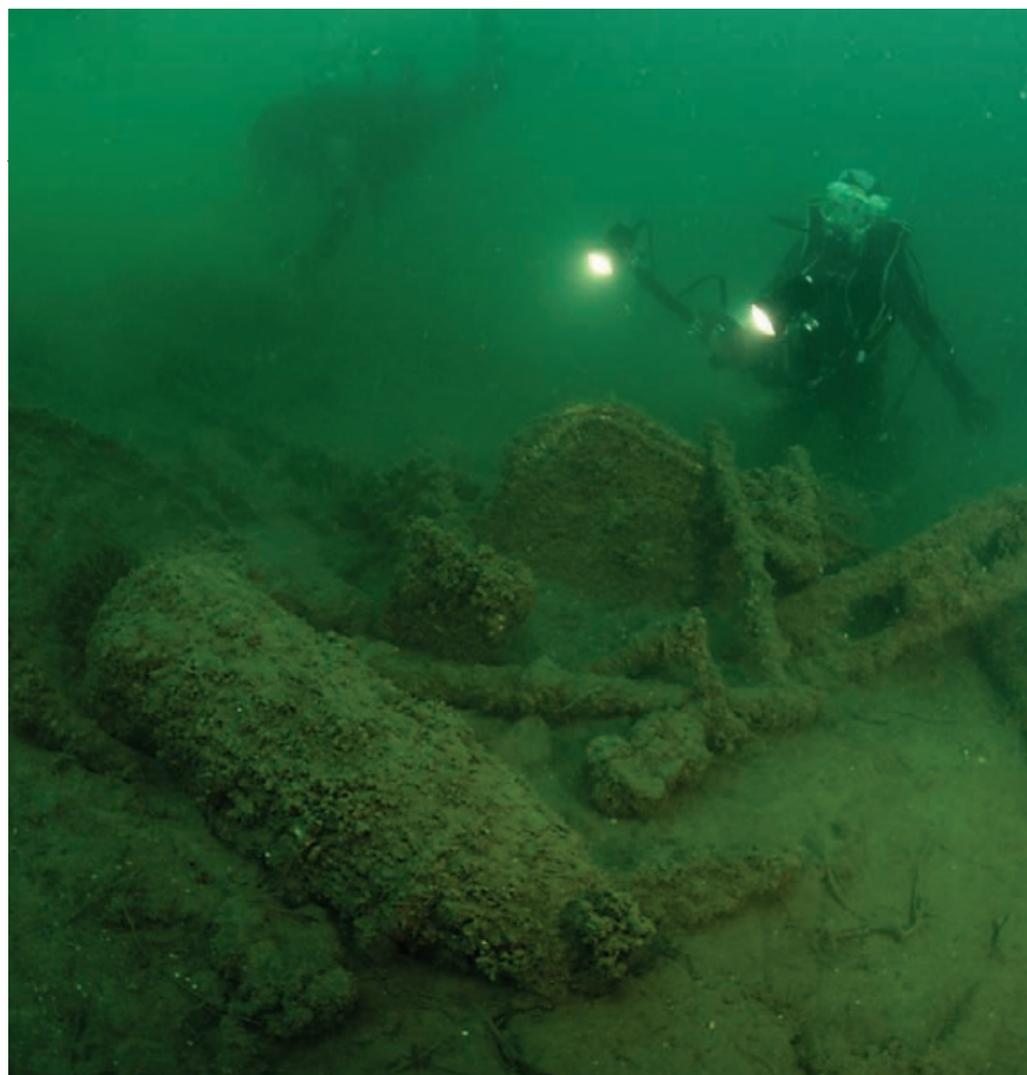
Fot. 36 *Mesudiye*, shell - caliber 234 mm

The most interesting discovery that our expedition made on the remains of the *Mesudiye* battleship was finding main artillery shells, which at the time of sinking, in principle, should not have been on onboard because - as mentioned earlier - its 234 mm caliber have been removed before the outbreak of the war. Meanwhile, these shells are still on the ship. In September 1914, Turks, under pressure from the Germans, decided to send *Mesudiye* to the Dardanelles, knowing that the main guns of the battleship would never return to their places. They did have enough time, however, to move useless ammunition onto land. Our expedition proved that no one on the staff of the Ottoman navy, however, went to the trouble of giving such an order. Today, we will probably not find out whether this was due to an oversight, or from excusable omission in this case (in the whole Ottoman Empire there were only two 234 mm caliber guns - both on the *Mesudiye* battleship - so moving the ammunition to the land did not serve any purpose because there would also be no use for them there). Due to the condition of the wreck, we are not able to authoritatively determine the spot where individual shells are in this "junkyard." Given that the 234 mm gun turrets were at the bow and the stern of the ship, we can, with great probability, assume that the places where we found shells correspond to these sections of the battleship. In addition to the main artillery ammunition, we also came across shells of a 150 mm caliber.

We measured all of them exactly. Already very heavily overgrown with marine organisms, the 234 mm caliber shells are currently at approximately 87 cm in circumference and 95 cm in length, while the 150 mm caliber shells average a 57 cm circumference. We were not able, however, to determine exactly how many shells of a given caliber lay on the wreck. There are definitely a few of the bigger ones, and a dozen of the smaller. Therefore, we can confidently conclude that our findings complemented - which already seemed very rich and difficult to expand - the pages of history of the duty of the *Mesudiye* battleship.

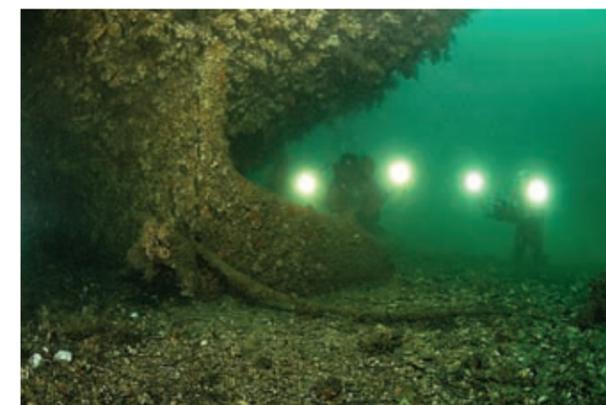
Fot. 40 *Tenedos*, rudder

The fact that *Halep* and *Tenedos* were attacked at a short interval, suggests that they were anchored close to one another. The wreck that we explored lies very close to the European shore at the position of 40°13'393 "N 26°25'39E and at a depth of 13.5 meters. Thus, all of the evidence indicates that it is *Tenedos*. For the place where she is located and the cause of her sinking, her condition can be considered relatively good. The stern, the power screw and the rudder tilted to the maximum right position are intact. Most importantly, they are facing in the direction of the strait, which is contrary to the position at which *Halep* sank. Three-fourths of the height of the rudder and the propeller are buried in sand. The hull, from the stern to the amidships, is also in good condition. Many of the portholes, still containing the glass, have been preserved on the sides.

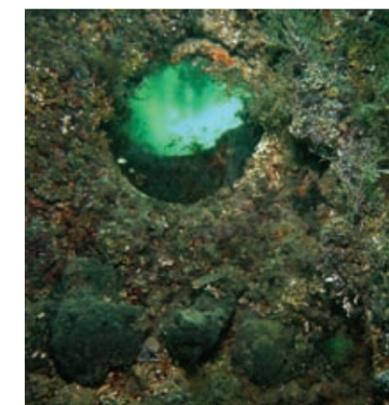
Fot. 41 *Tenedos*, porthole

Reaching them, however, is not easy, since most of them are covered with marine organisms, profusely growing on the ship's sides. The wooden deck no longer exists, and the interior of the wreck is full of seashells deposited by currents and storms. Above the deck, unfortunately, nothing is preserved any longer. The reasons for this are, of course, storms and people, who robbed the wreck of her precious metal parts protruding above the water's surface after sinking. Exactly on amidships, both of the sides of the wreck are very strongly bent. According to our evaluation, the force of the torpedo's explosion lifted the ship causing

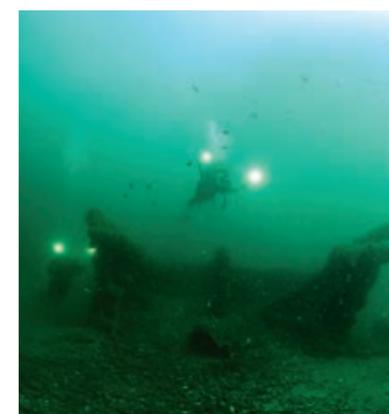
Fot. 42 *Tenedos*, remains of the bow

the characteristic bends in her central part (i.e. the bow, where the hit occurred, was raised above the water's surface, while the heavy stern still remained in the water). Swimming further in the direction of the bow, at a length of about 25 meters from the bent sides of the amidships, the shape of the hull and the remains of the decks can still be easily recognized. Most portholes have, unfortunately, broken glass. The part of the bow, or rather most of the front part at a length of 56 meters, does not exist. Only 49 meters of the length of the wreck have been preserved, which may indicate that, at the time of the torpedo hit, the ship still had a large cargo of ammunition under the deck imported from Istanbul for the soldiers fighting on the Gallipoli Peninsula.

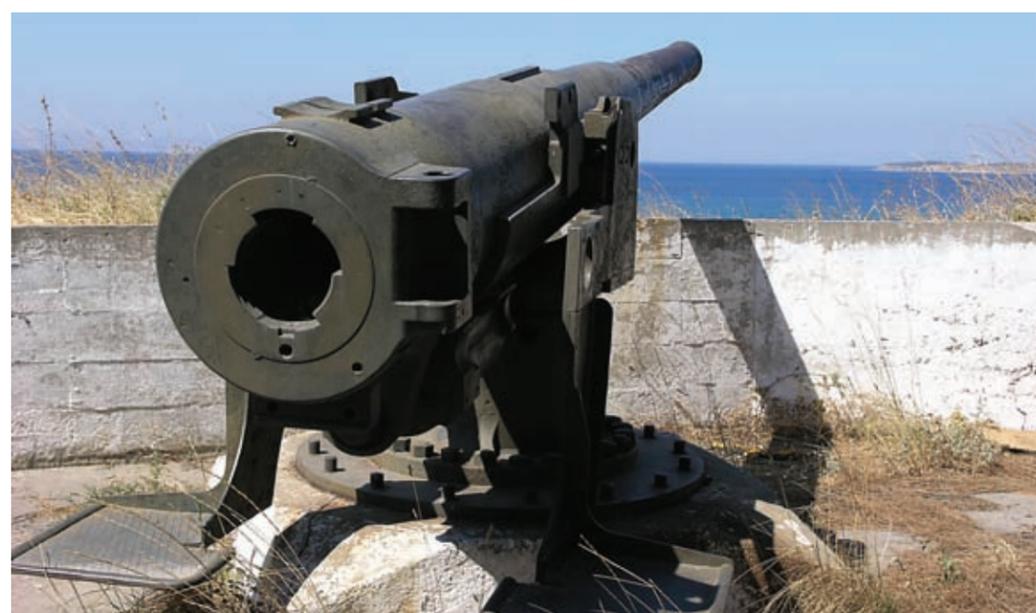
Fot. 45 Fort Orhaniye, a 150/40 gun from battleship Mesudiye

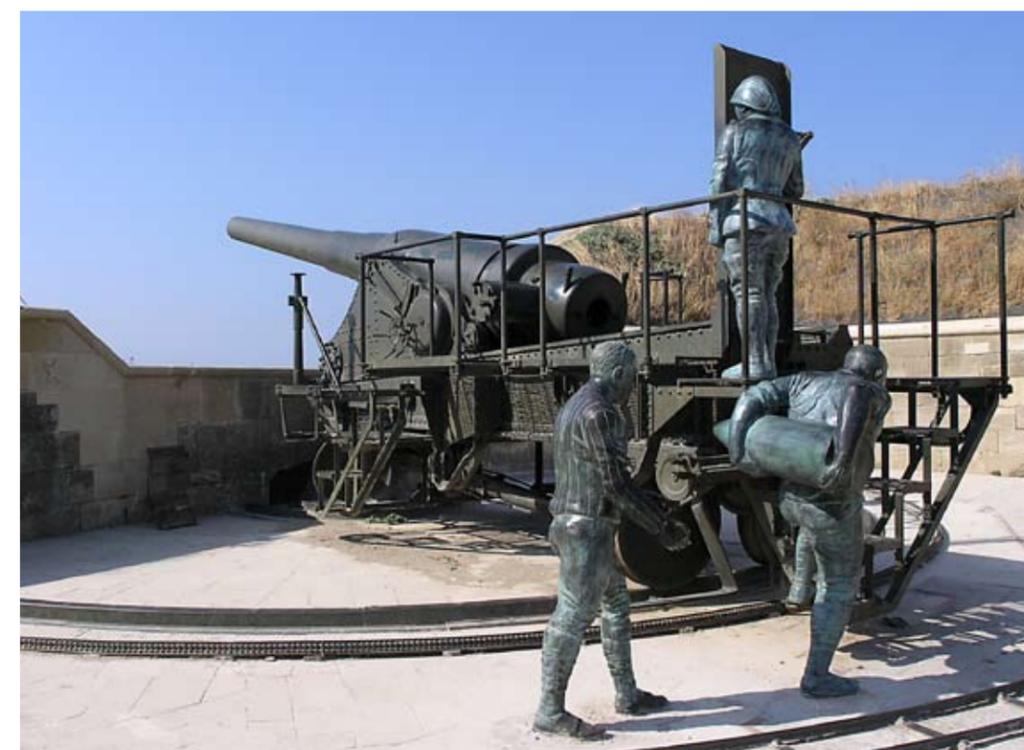
Fot. 46 Fort Rumeli Mecidiye, a 240/35 Krupp gun
