# ORP Kujawiak L-72

FINAL REPORT OF THE FLAG Nos. 207 and 212  
Four Expeditions

This report is the result of four expeditions to the island of Malta on the Mediterranean Sea in 2014, 2015, 2016, and 2017. During the four expeditions, honored by The Explorers Club Flag, the Shipwreck Expeditions Association team was able to discover the shipwreck of the Polish escort destroyer ORP Kujawiak – L-72. She lies at a depth of 330 feet, five nautical miles northeast of Valletta, the capital of Malta. Not only did the team explore the wreck for the first time, they also collected unique video and photo materials of the entire shipwreck, made a 3D image of the whole deck, and produced a 40-minute documentary movie. The team takes pride in their commemoration of the thirteen fallen Polish servicemen by funding and unveiling a marble plaque with all of their names in a very honorable place – the Upper Barrakka Gardens in Valletta. We also placed a bronze plaque as well as the flag of the Polish Navy on the wreck in order to further commemorate the fallen at their final resting place. During the third expedition, the team was able to find the ship's bell in a very inaccessible place. We reco

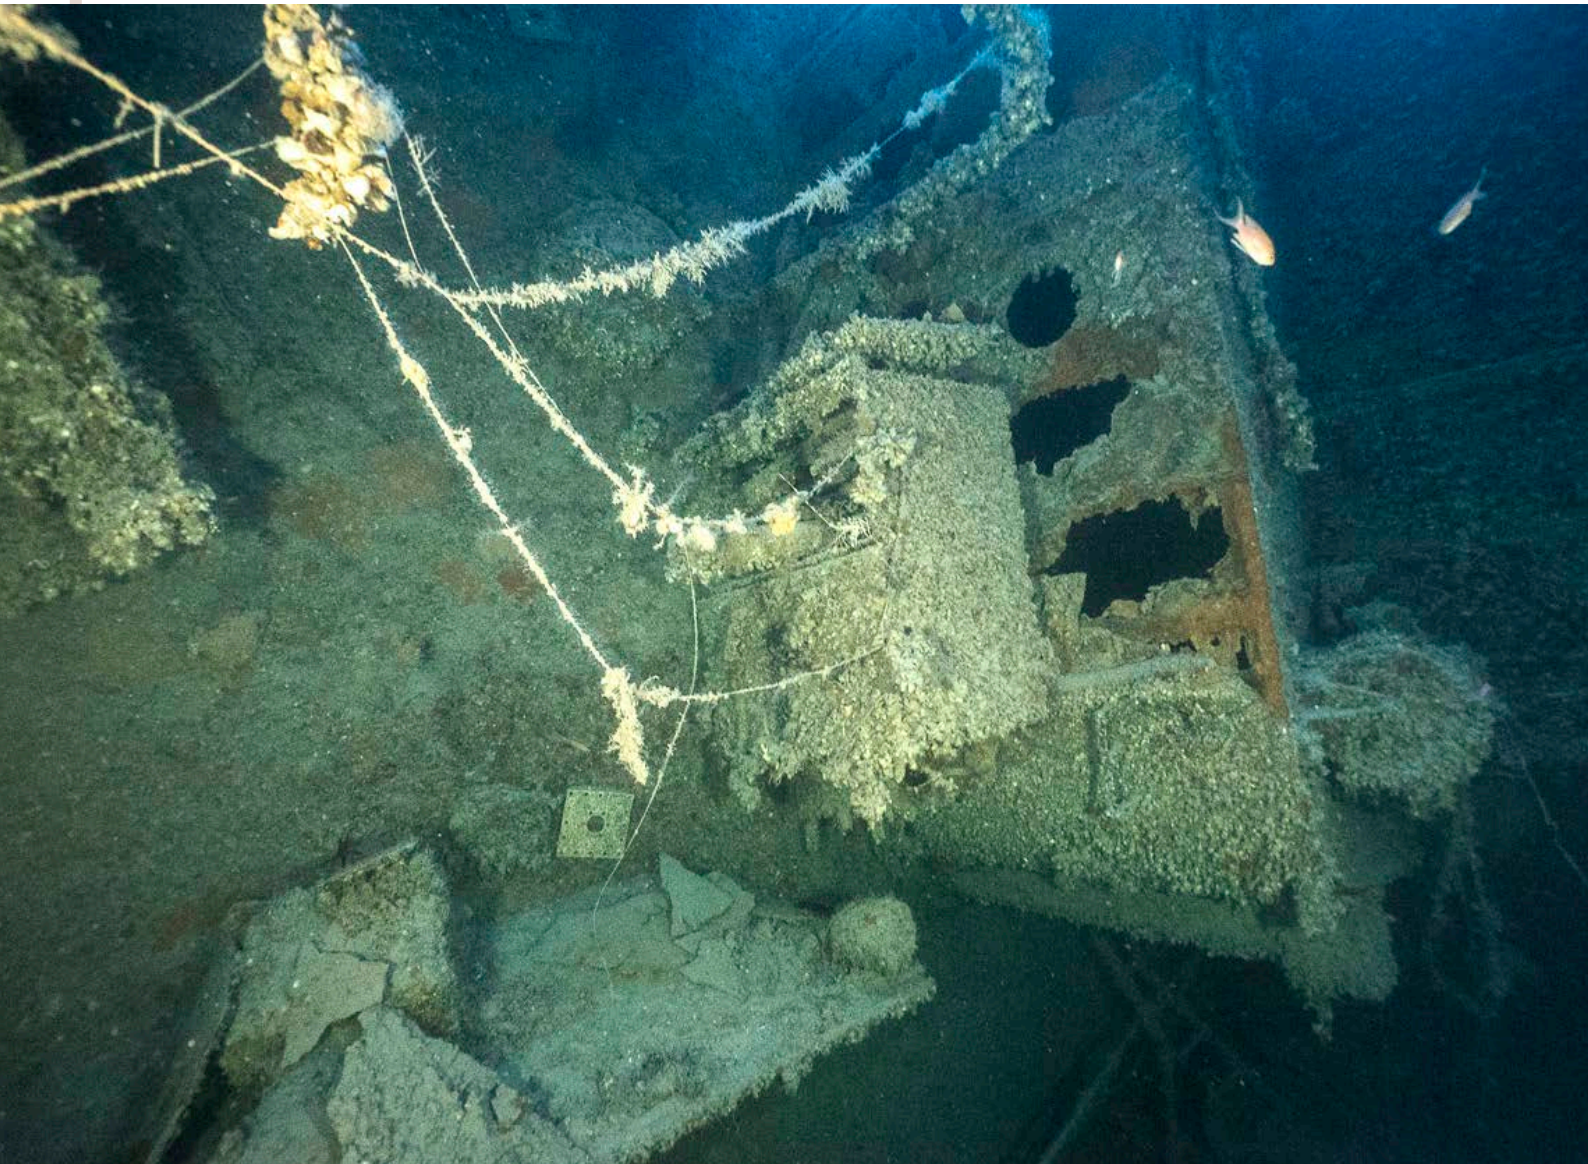
The ship's bridge is also in great condition – the winch, the portholes, and the Duty Finder Coil are all very easily recognizable.

Photo: The forward part of the ship's bridge. (photo: J. Wood)

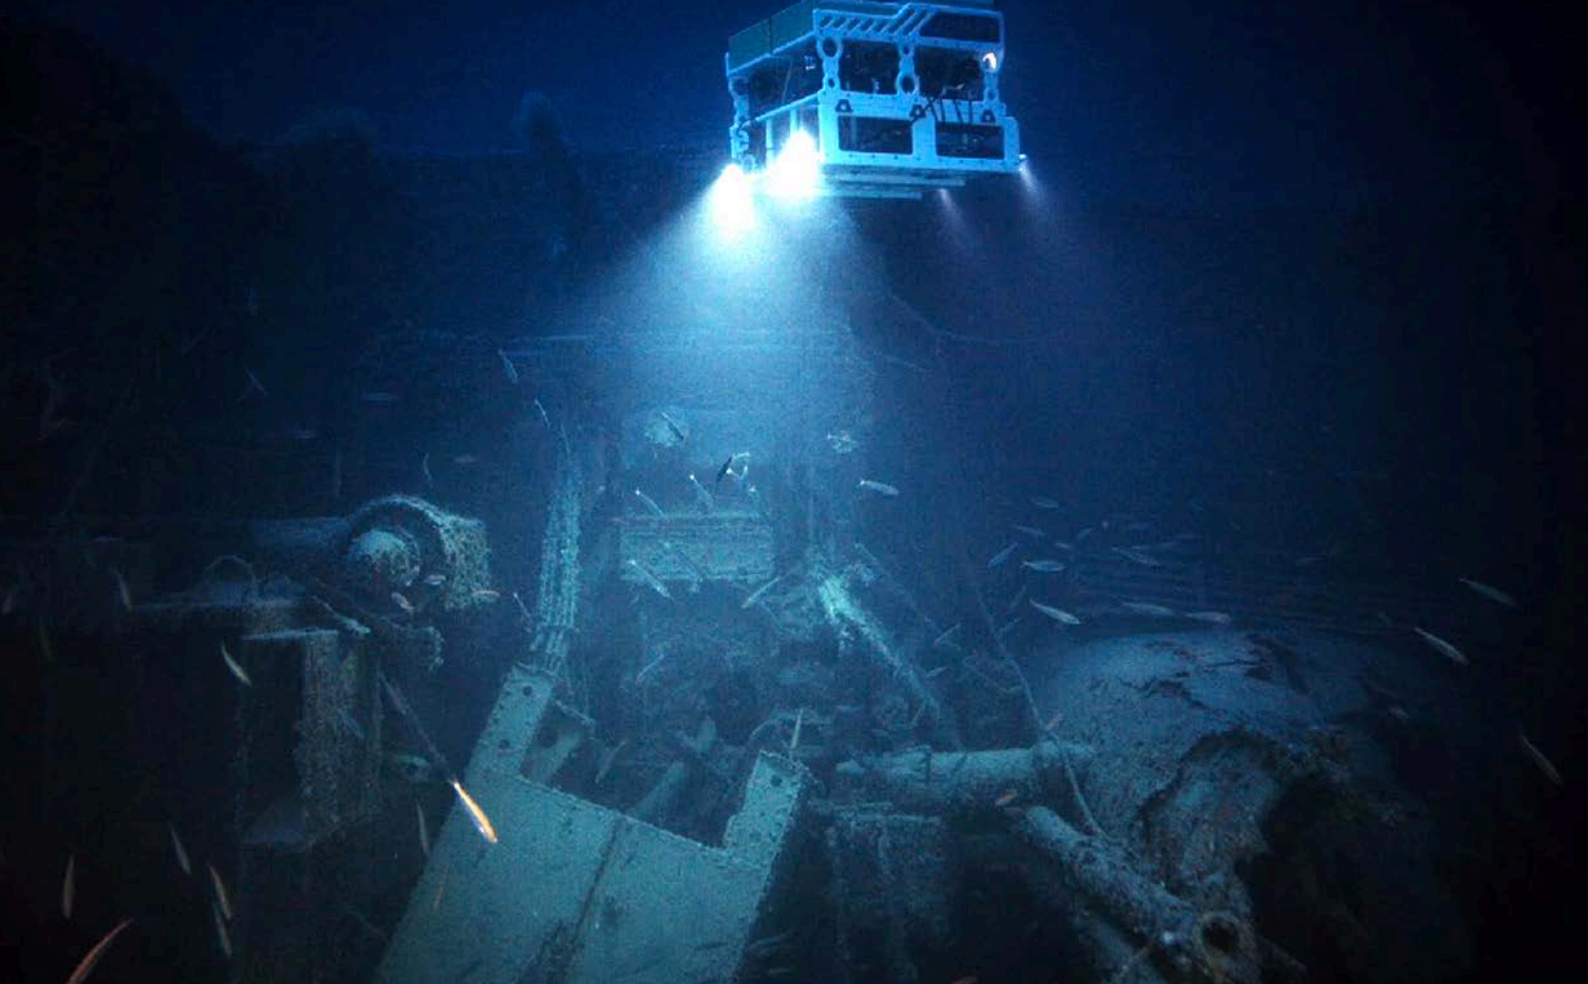
The starboard cannon is barely visible, mostly buried in the sand. After the bridge, at midship, is the funnel, which is not in good condition as most of the sheathing is rusted out. On the left side of the funnel is a sizable wash deck locker, and next to funnel is the lumber rack whose shape resembles a slat bench.

**Photo:** Amidships at location of ship's funnel.. (photo: U-boat Malta Ltd.)

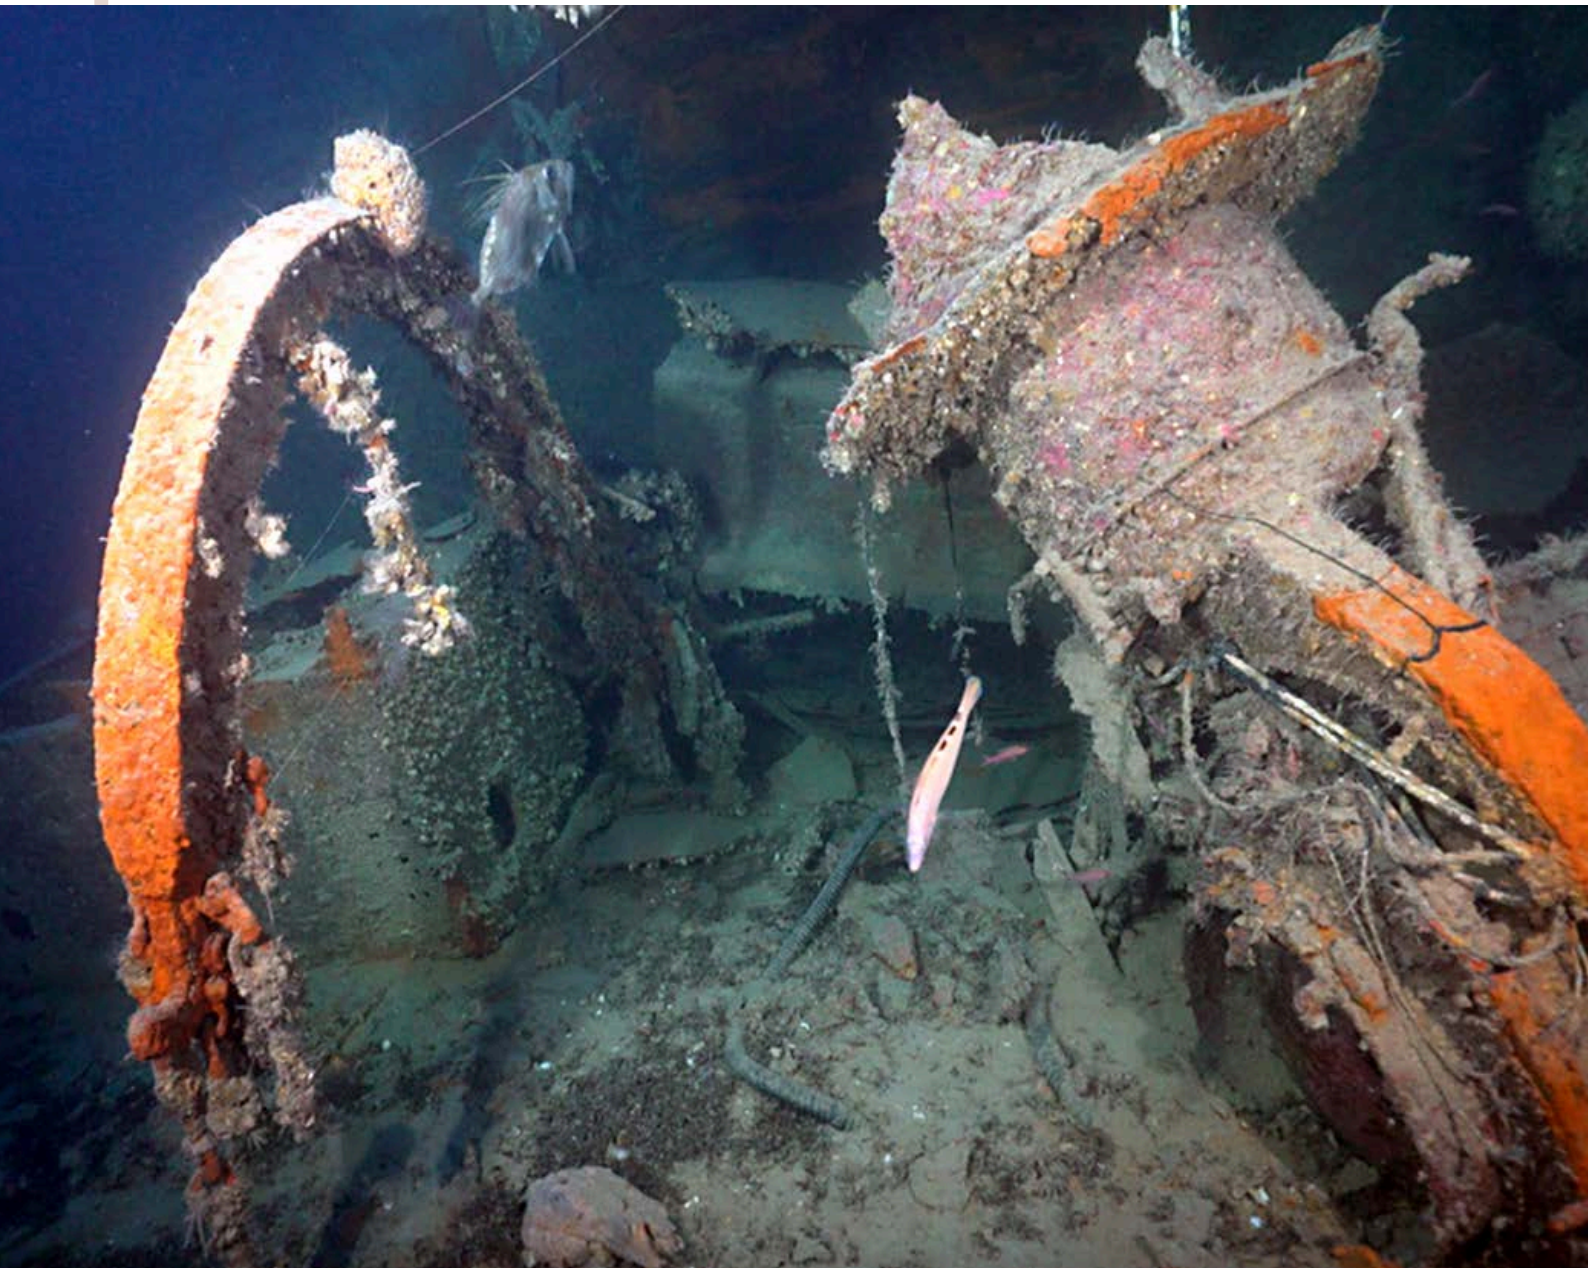
Photo 43: The remains of the searchlight and one of the davits (photo: K. Hyttinen)

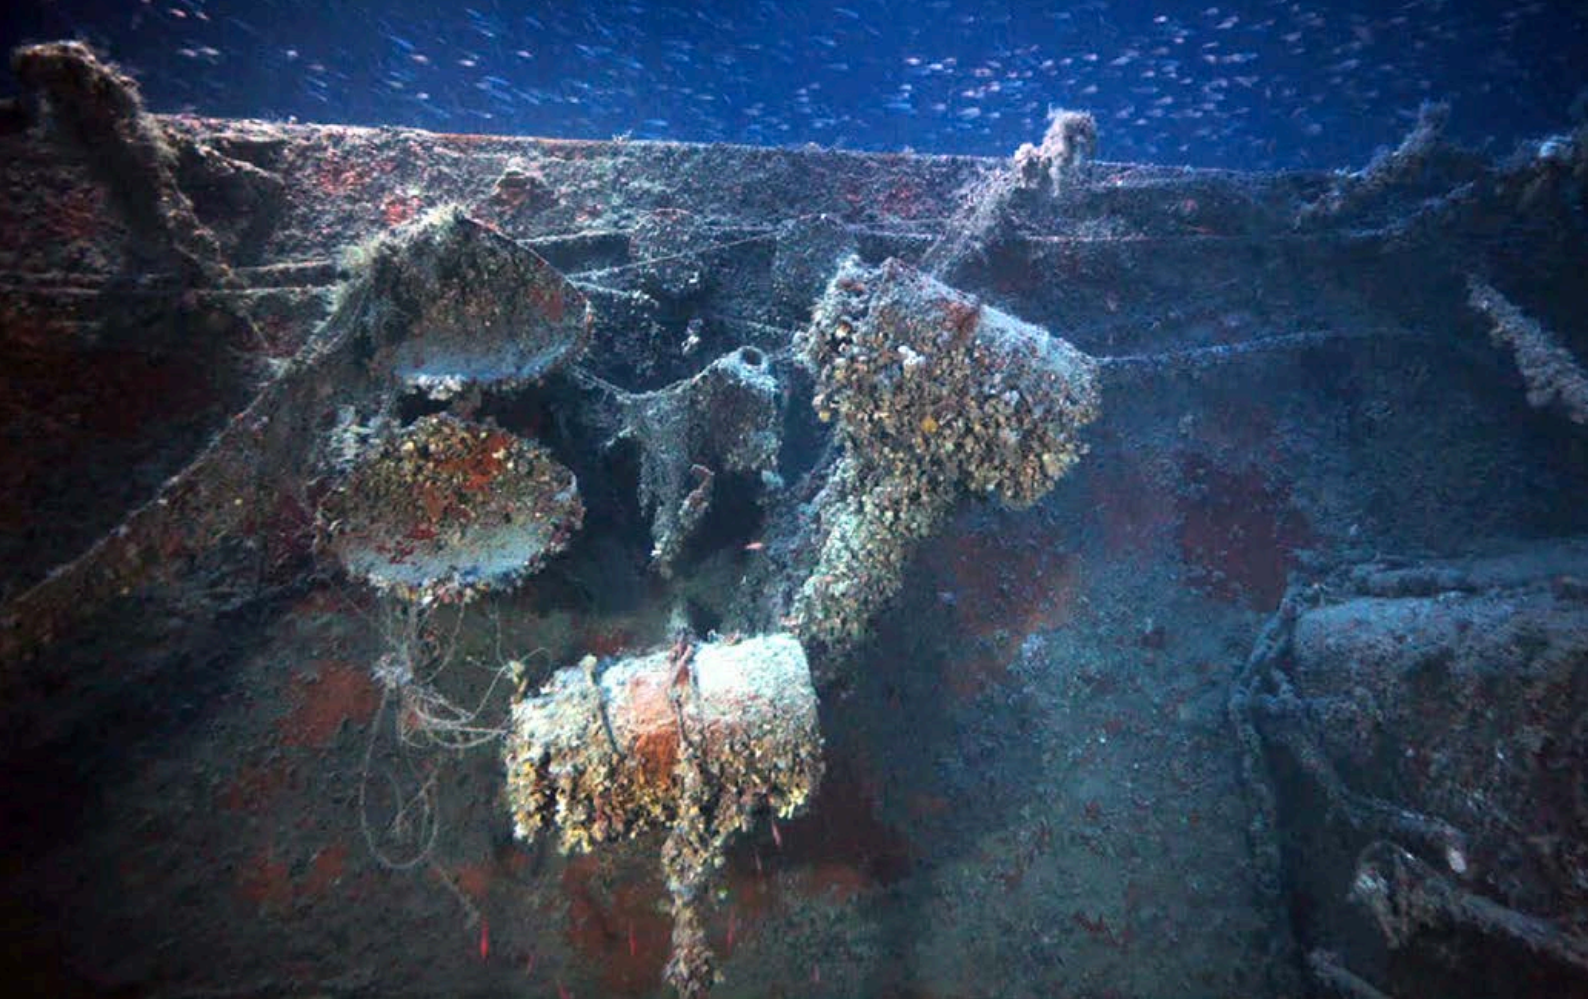
The second gun turret is sheltered by the gun's protective plate. The turret is, unfortunately, without its guns as the guns fell out when the ship hit the seabed and they lie a few meters away from the wreck.

Photo: The second gun turret without its guns. (photo: K. Hyttinen)

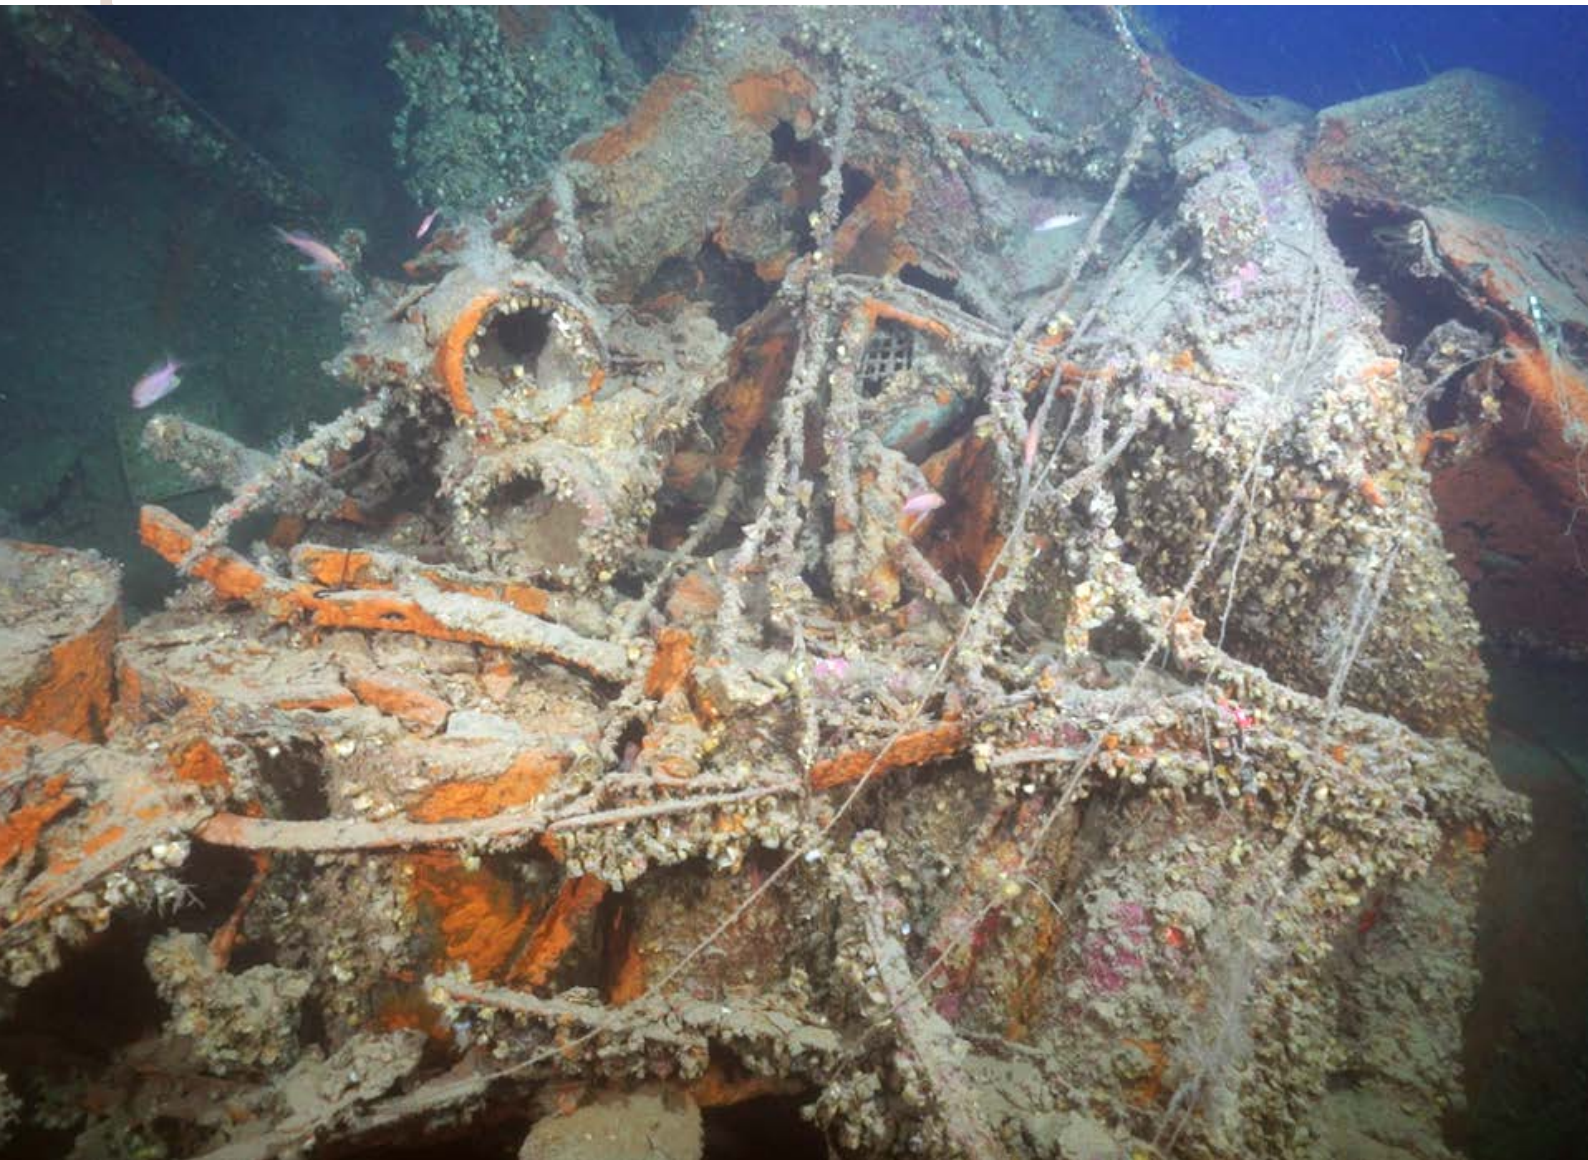
On top of the guns from this station lies a part of the construction of the second gun platform. The ship's stern is in the worst condition. Here are the twisted rails of the depth charge racks with the depth charges trapped inside, as well as the remains of the depth charge projectors.

Photo: The stern of the ship and the twisted rails of the depth charge racks with the depth charges trapped inside. (photo: K. Hyttinen)

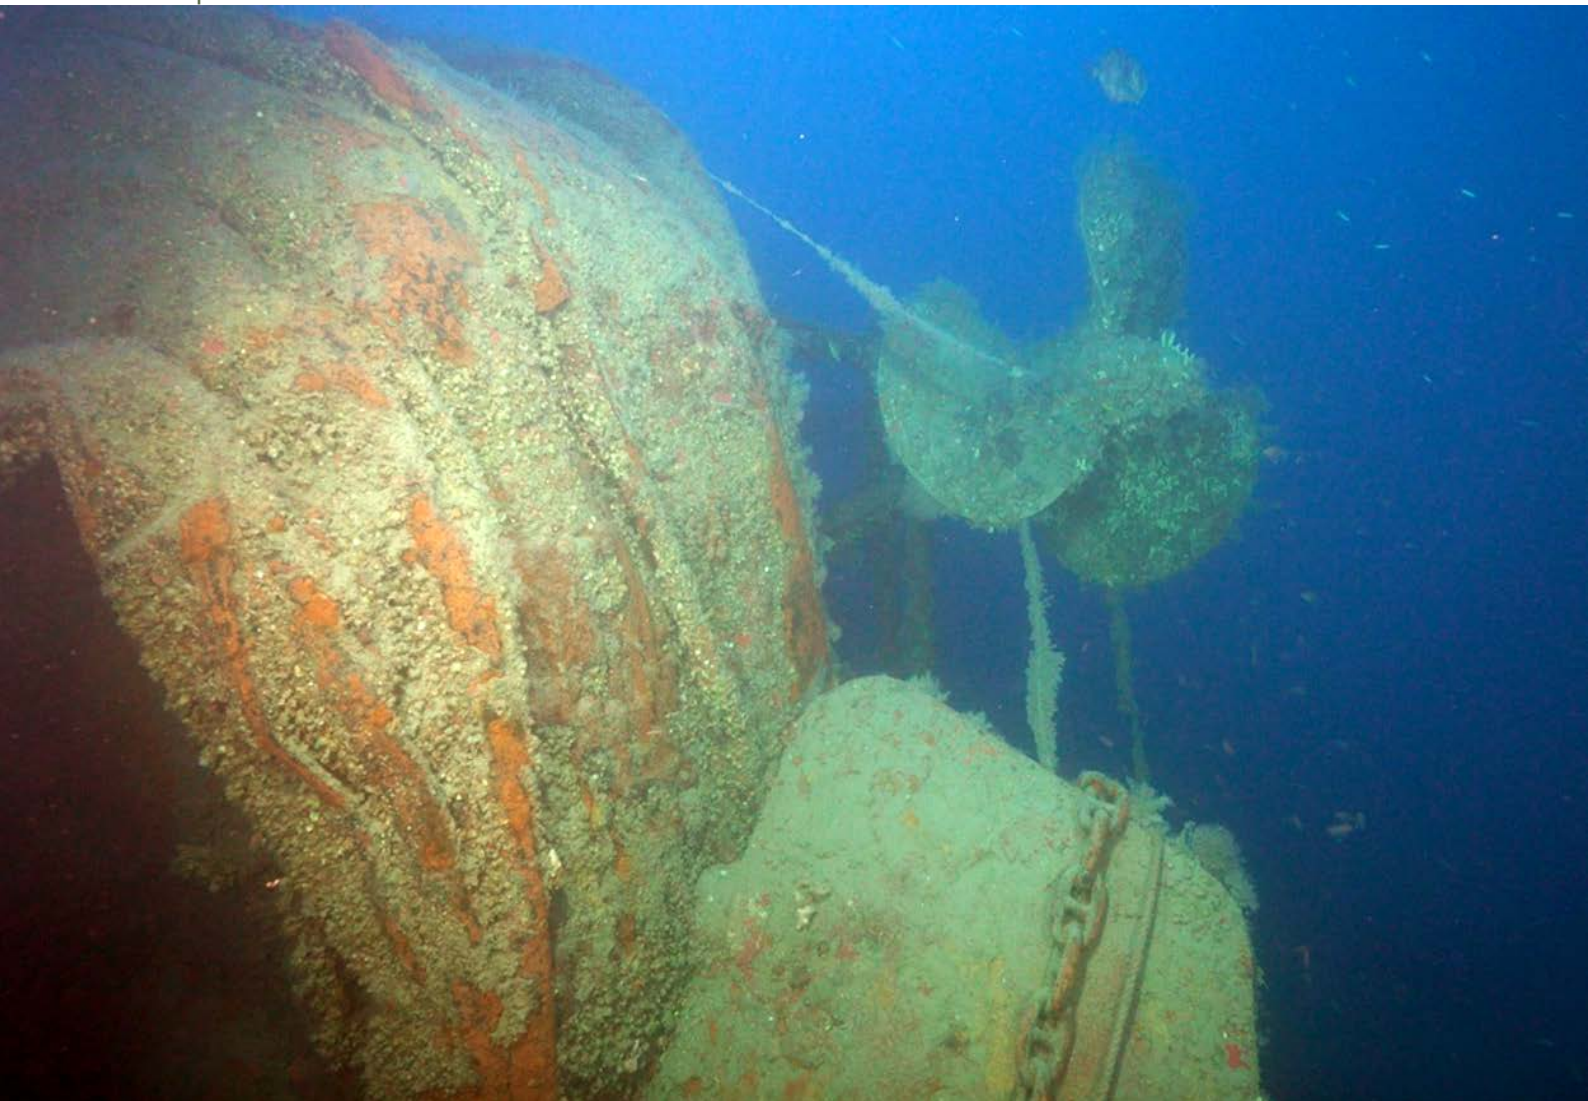
**Photo:** The characteristic impact buckles on the stern, the rudder and one of the propellers. *(photo: K. Hyttinen)*

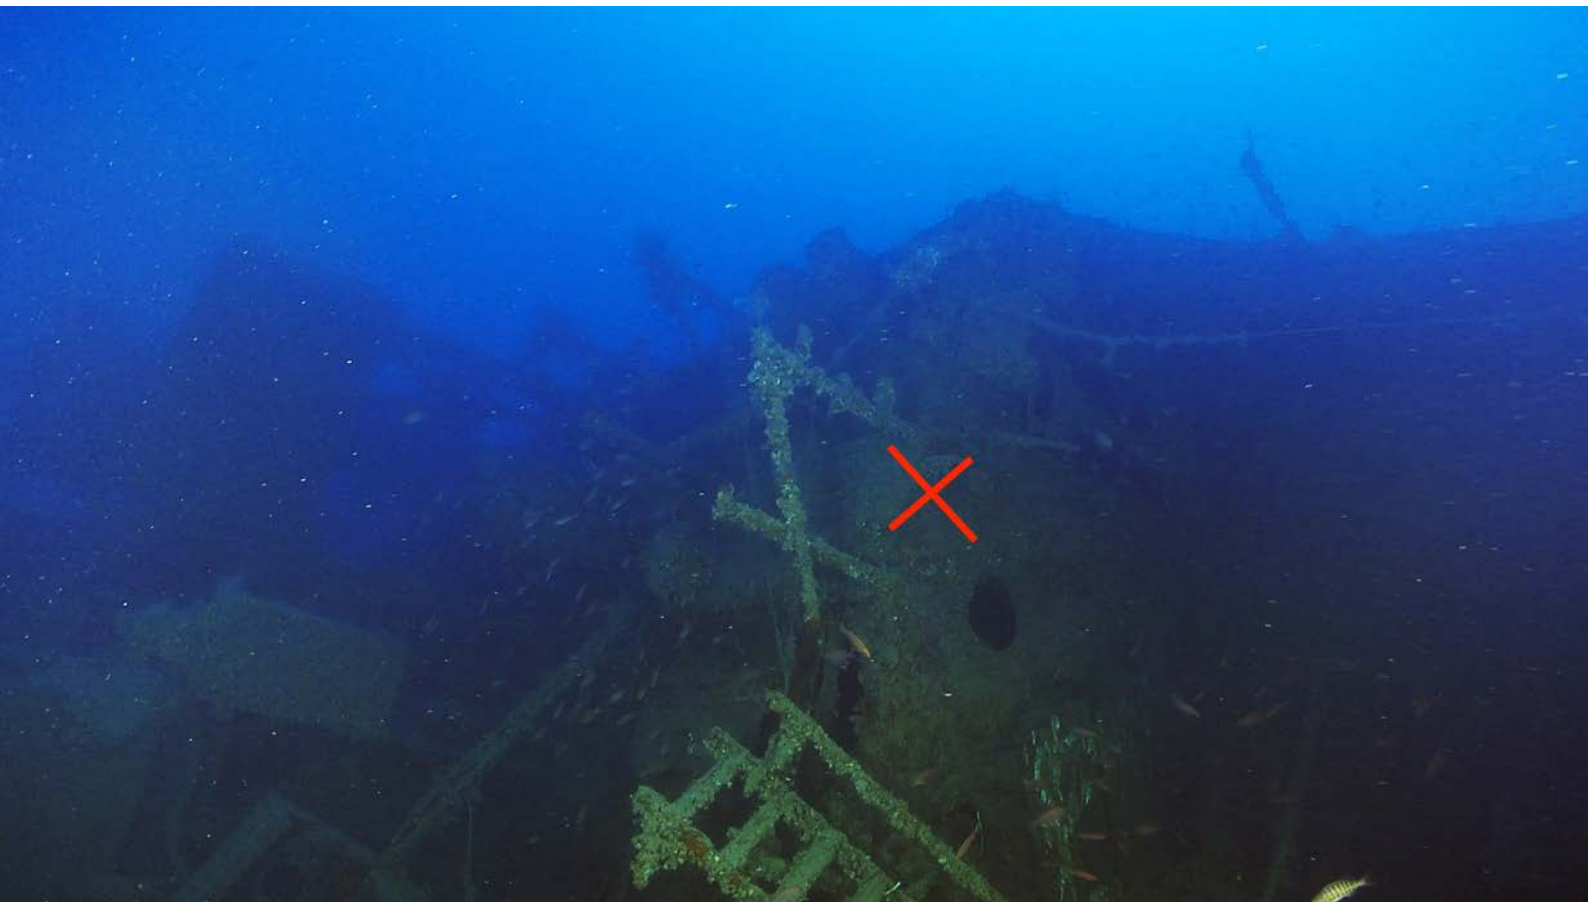
After analyzing the video material we knew that the seabed below the spot where the bell should be mounted was empty as well. The team was afraid that the bell could have disconnected from the ship during the sinking and ended up far from the wreck making it impossible to locate.

Photo: The spot on the wreck marked by an X where the bell should be attached. (photo: G. Iaria)

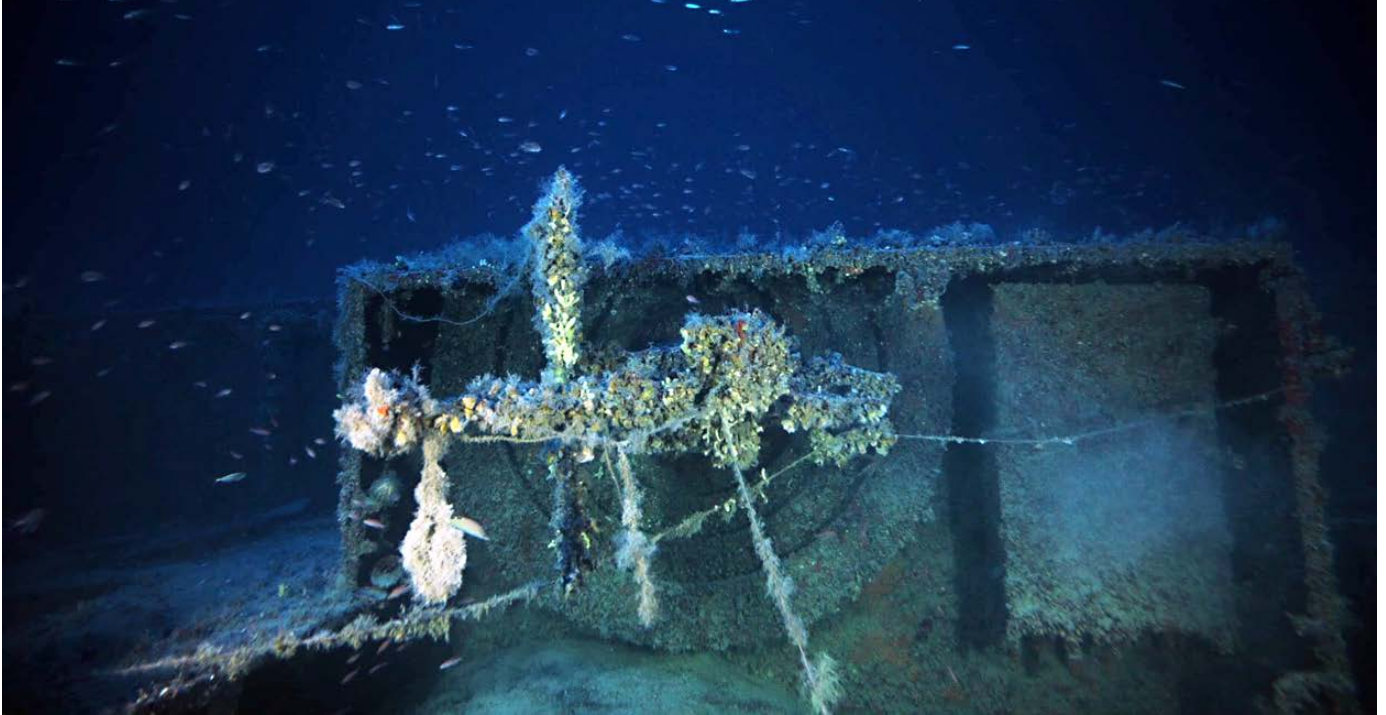
Photo: The starboard anti-aircraft 20mm Oerlikon cannon in 2015 before damage. (photo: U-boat Malta Ltd.)

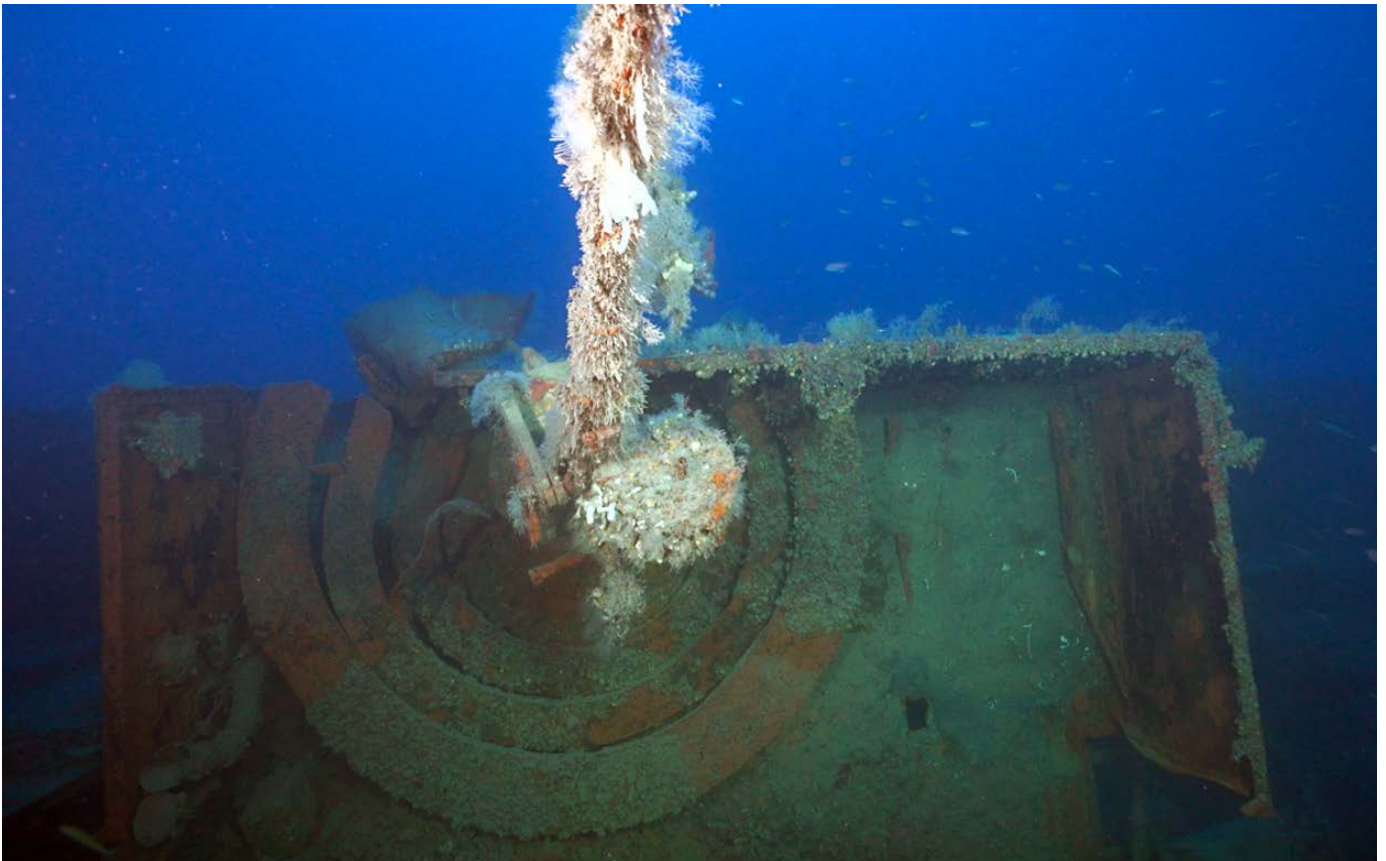
1. The starboard anti-aircraft Oerlikon 20 mm gun station has been destroyed by, most likely, an anchor. The sheets of metal around the gun are torn and bent up towards the top. The base of the gun is destroyed and the gun itself changed its angle. Also, the ammunition box located on the right side of the station is no longer there.

Photo: The same cannon in 2017 after damage. (photo: K. Hyttinen)

The damage of the Oerlikon gun station suggests that a large vessel pulled its anchor and irrevocably destroyed this part of the wreck. Also, a large vessel anchor caught the chain of Kujawiak's starboard anchor and moved it, which can only mean that commercial vessels are parking above the wreck. All of this damage must have taken place between the second exploration of the wreck in 2015 and the fourth expedition in 2017. There is no doubt that further devastation of the wreck will continue in the future. Most importantly, there are a lot of explosives onboard the wreck and in its vicinity, including many depth charges, 102 mm gun shells, and 20 mm and 40 mm anti-aircraft gun ammunition. Their contact with heavy anchors could be dangerous and devastating

This shipwreck is a war grave, so it should not only be treated with the utmost respect, but it should also be placed under special protection. In 2015, both the Polish and Maltese governments agreed to protect this site, and after the last expedition in 2017, the Shipwreck Expeditions Association requested that the Maltese authorities establish a “No Parking Zone” in the vicinity of the wreck.

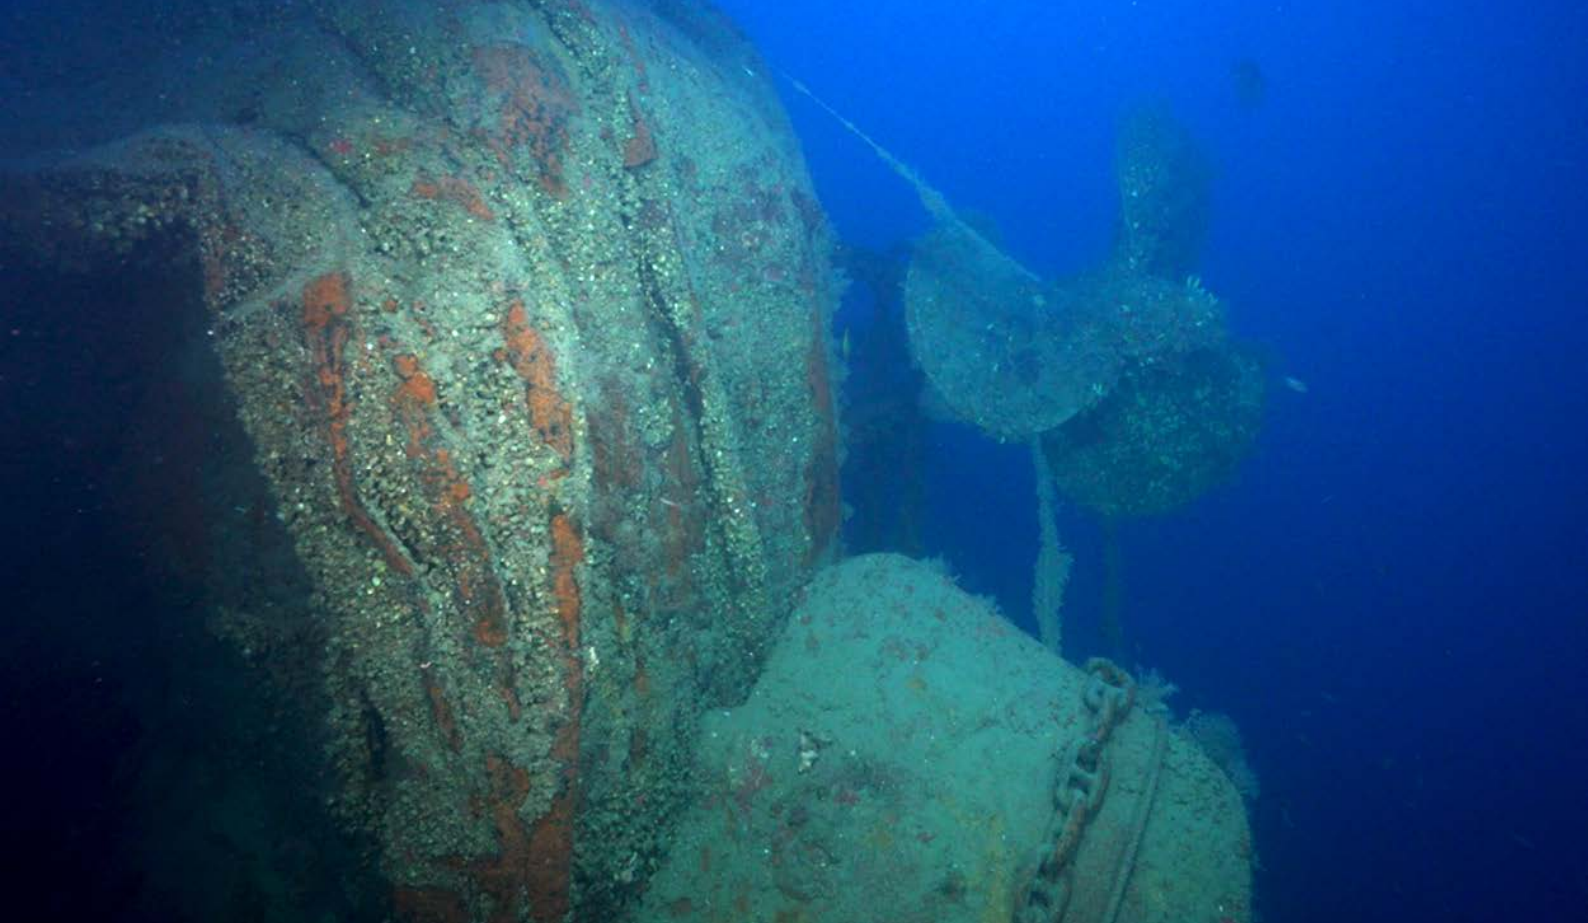
2. The ship's heavy anchor chain from the starboard anchor was moved by a large vessel anchor and now lies on the wreck's rudder, propellers, and the prop shafts

Photo: The rudder in 2017 with the chain. (photo: K. Hyttinen)

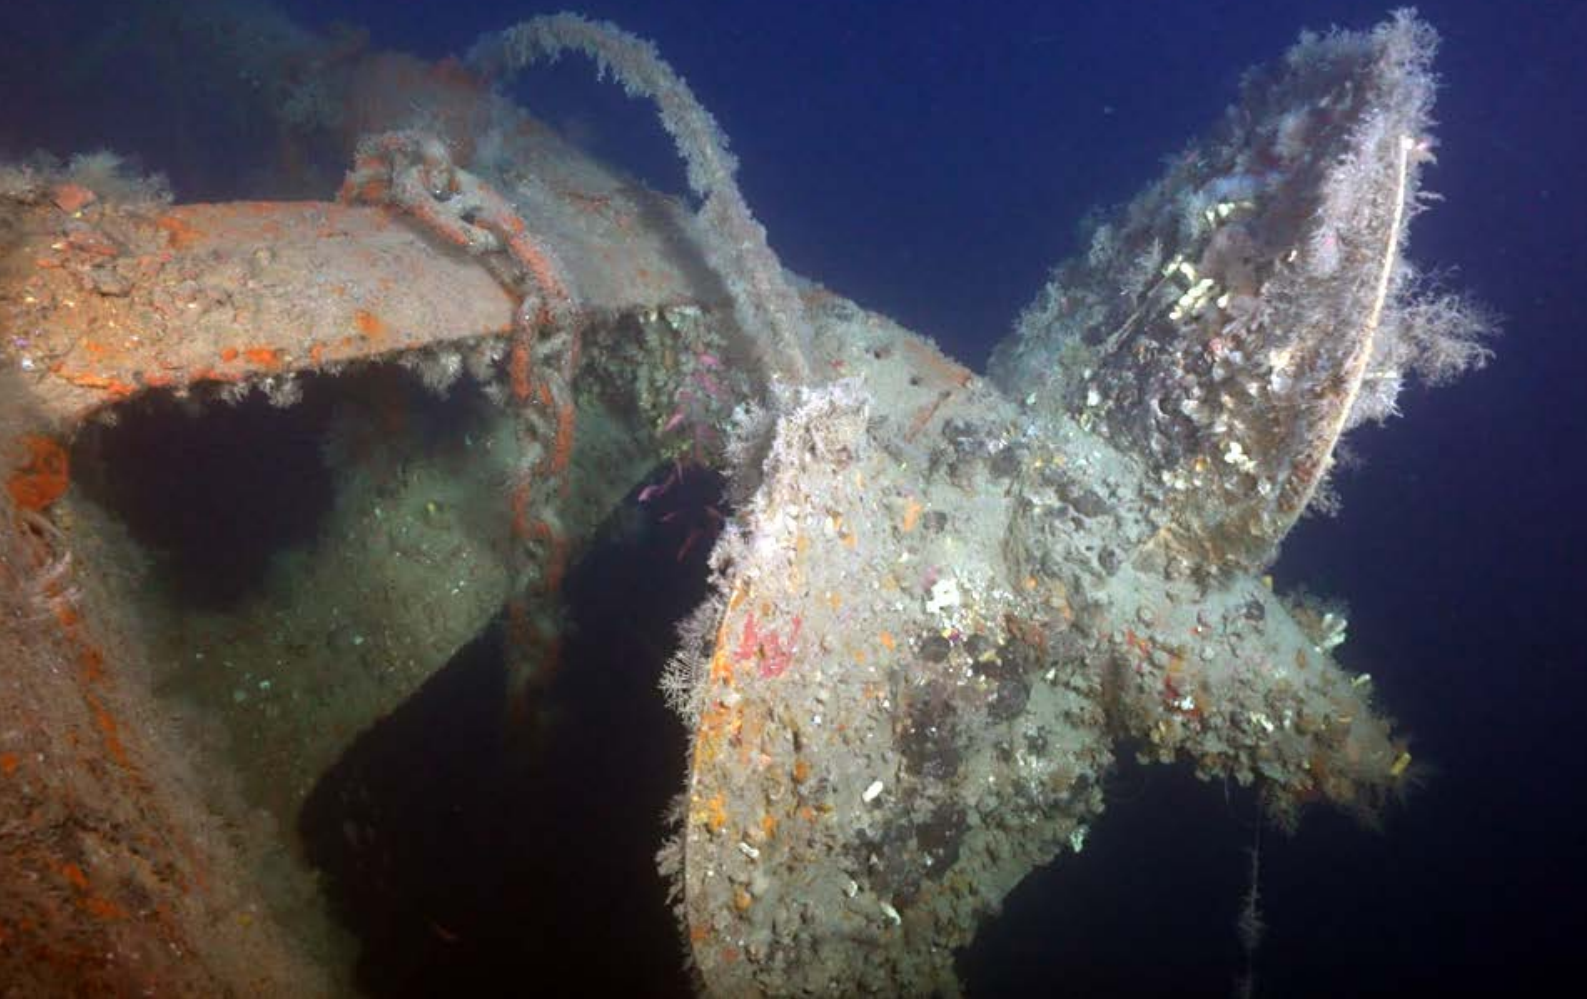
**Photo:** The chain on the ship's propeller support bracket in 2017. *(photo: K. Hyttinen)*

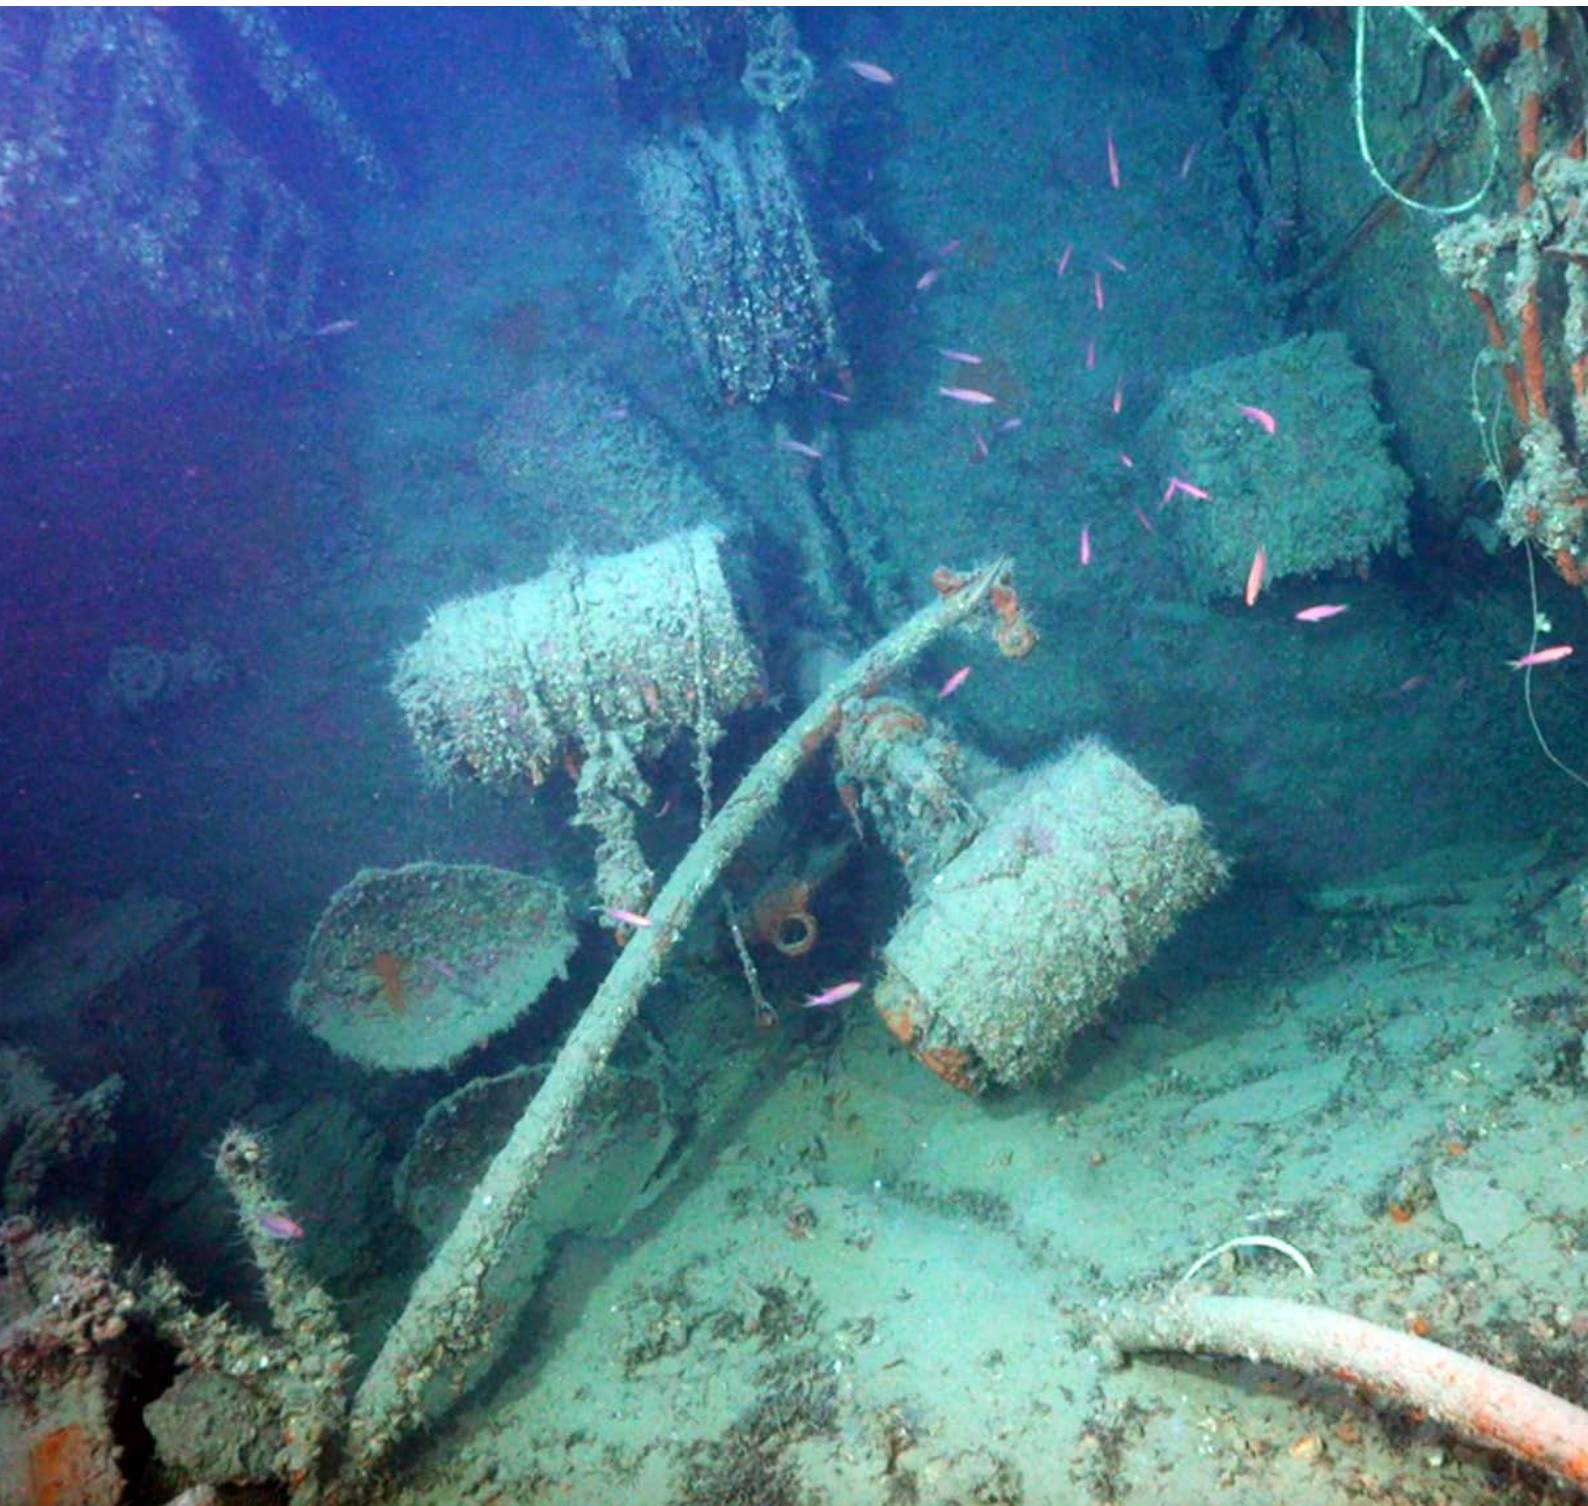
Photo: The portside two depth charges in their projectors. (photo: K. Hyttinen)

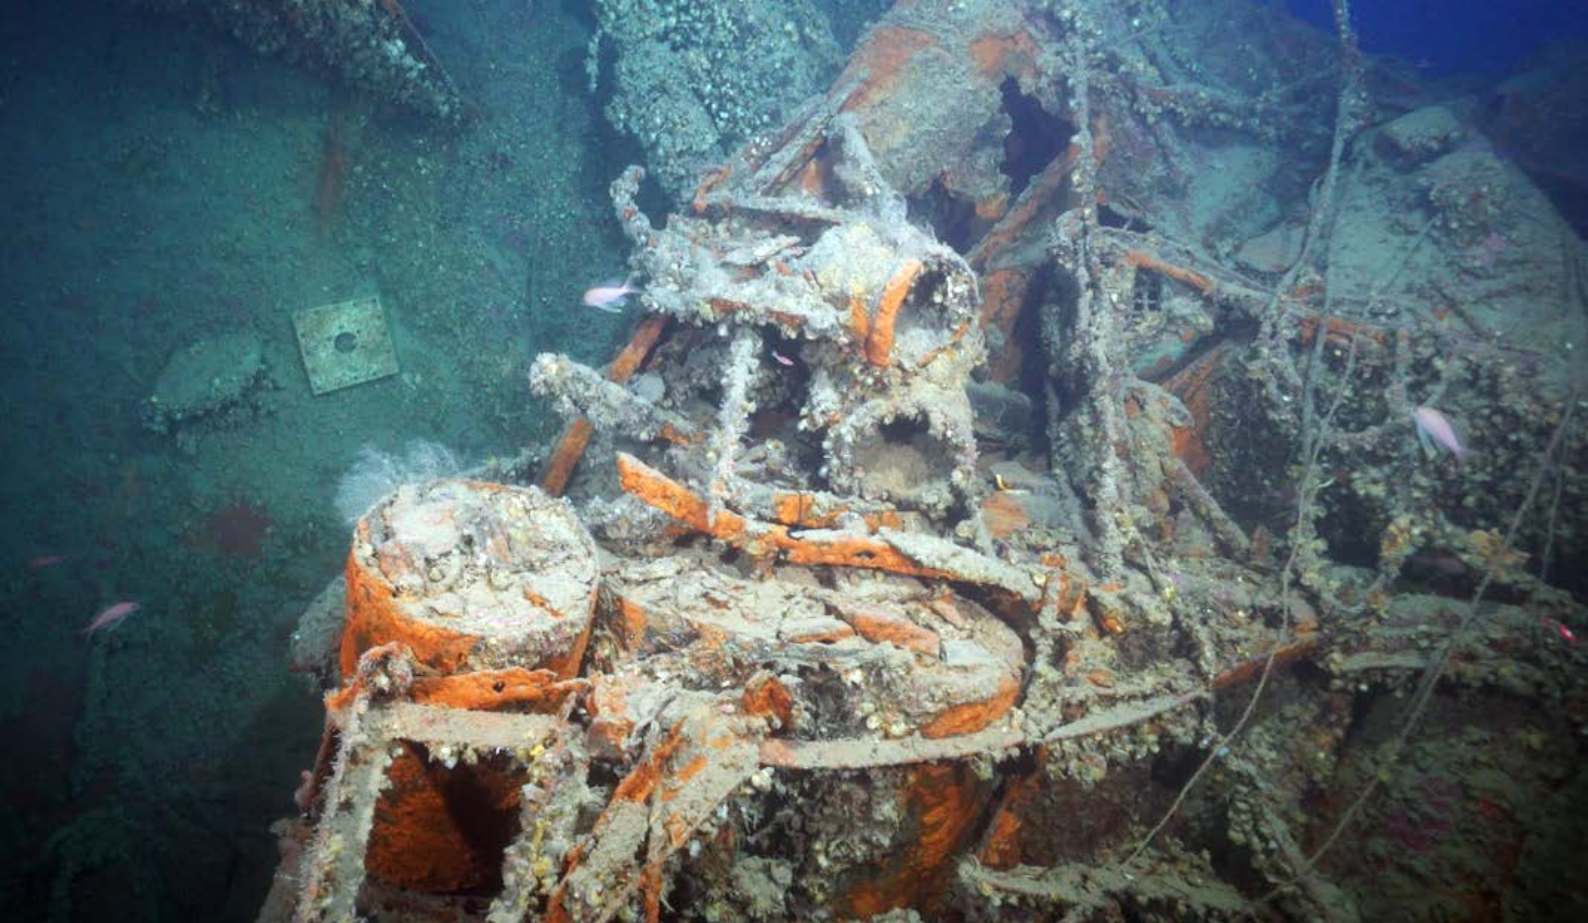
Photo: The twisted tracks of the depth charges on the stern with the depth charges trapped inside. (photo: K. Hyttinen)
