# ORP Kujawiak L-72

FINAL REPORT OF THE FLAG Nos. 207 and 212  
Four Expeditions

This report is the result of four expeditions to the island of Malta on the Mediterranean Sea in 2014, 2015, 2016, and 2017. During the four expeditions, honored by The Explorers Club Flag, the Shipwreck Expeditions Association team was able to discover the shipwreck of the Polish escort destroyer ORP Kujawiak – L-72. She lies at a depth of 330 feet, five nautical miles northeast of Valletta, the capital of Malta. Not only did the team explore the wreck for the first time, they also collected unique video and photo materials of the entire shipwreck, made a 3D image of the whole deck, and produced a 40-minute documentary movie. The team takes pride in their commemoration of the thirteen fallen Polish servicemen by funding and unveiling a marble plaque with all of their names in a very honorable place – the Upper Barrakka Gardens in Valletta. We also placed a bronze plaque as well as the flag of the Polish Navy on the wreck in order to further commemorate the fallen at their final resting place. During the third expedition, the team was able to find the ship's bell in a very inaccessible place. We reco

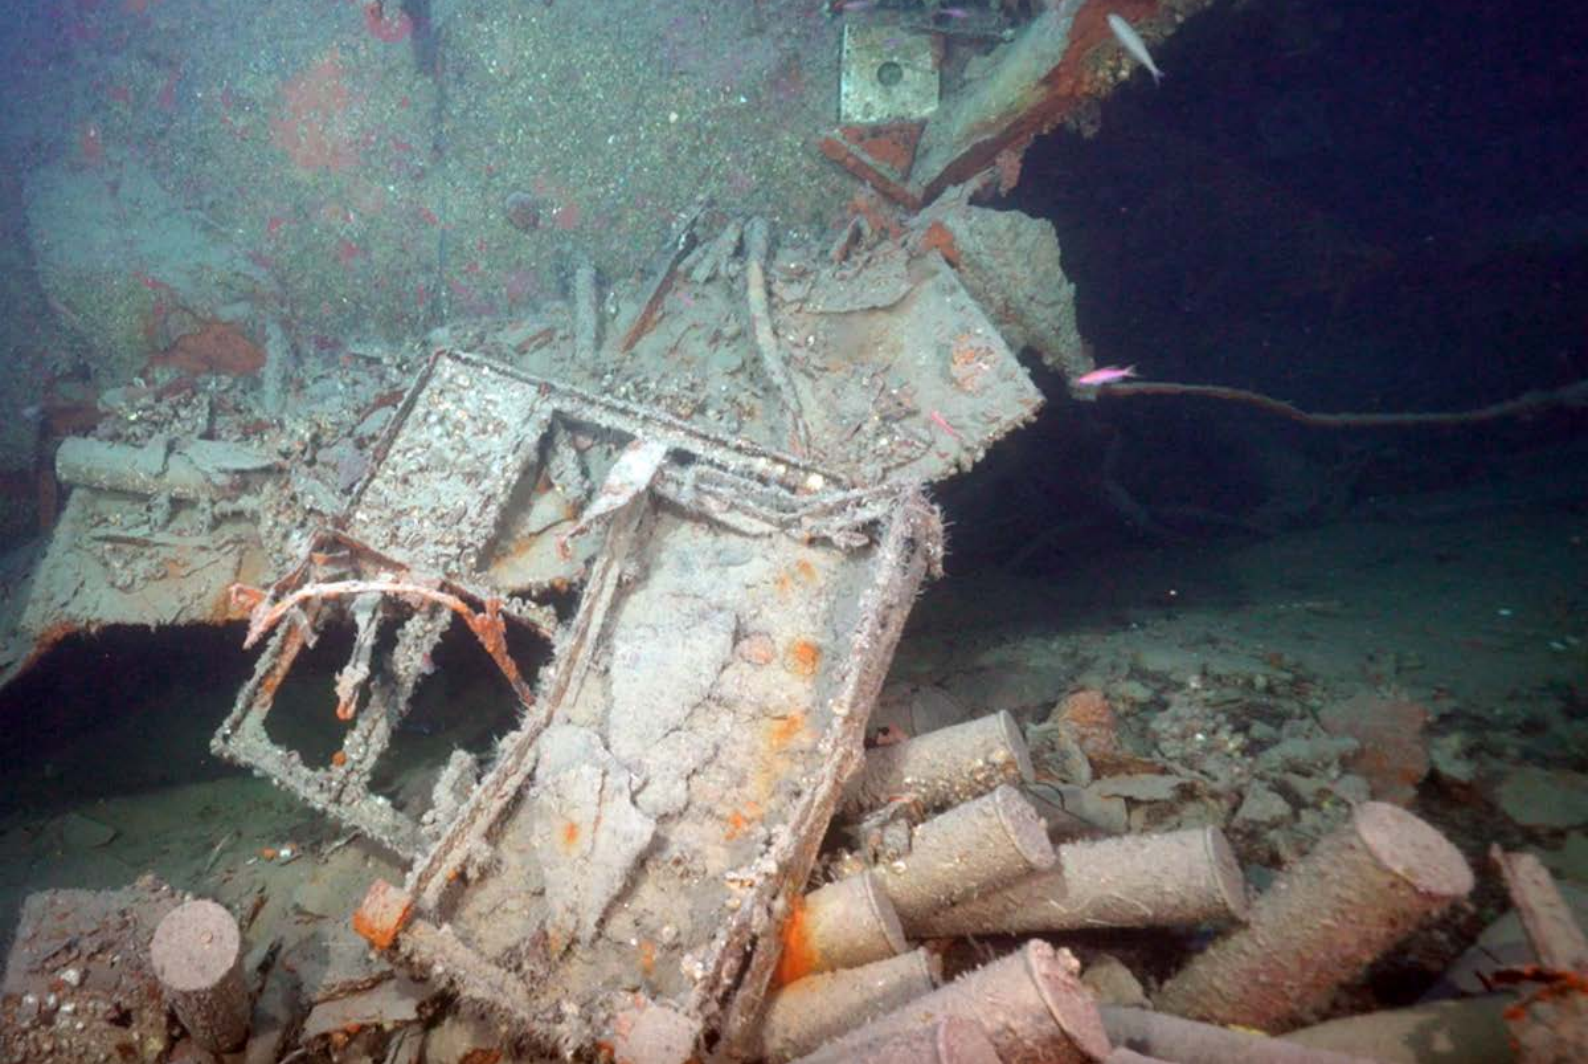
Down below this station are the gun shells that fell out of the ammunition box. Some lie on the gun's protective plate and several others stick out vertically in the sand. After the second gun turret is the third gun turret which is located the deck below and is in the great condition.

Photo: The 102 mm gun shells that fell out of the ammunition box. (photo: K. Hyttinen)

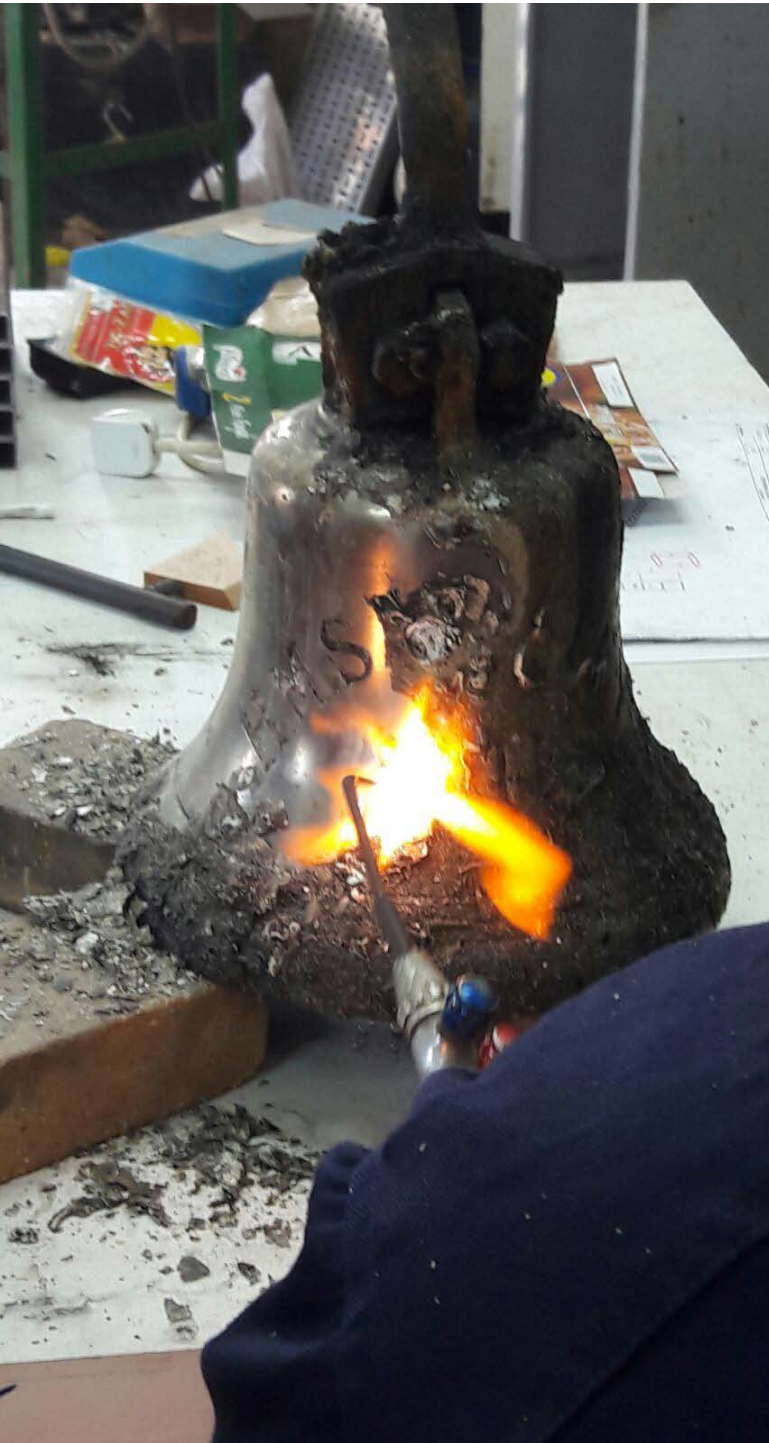
**Photo:** The heating method to remove the concretions outside the bell. *(photo: Heritage Malta)*

The bell was handed over to Heritage Malta in order to perform proper restoration. All cultural property coming from the sea requires extensive desalination and specialized conservation interventions. Failure to undertake professional conservation leads to the decay of the retrieved cultural heirloom and its accelerated deterioration and loss. The bell, covered with thick concretions, was retained within sea water until it arrived at Heritage Malta's Conservation Laboratories in Bighi, where it was placed in a desalination tank. Heritage Malta's qualified conservators investigated the bell's condition and further researched any possible interventions to be undertaken. Throughout the year the water used in the desalination tank was gradually changed from saline to deionized water, with weekly readings of the conductivity being recorded. Following various cleaning tests to remove the concretions, the conservators opted for an innovative process of using a surface heating method, specifically used for such metal items. The process was successful and most of the external and internal coverings were removed. This process revealed the inscribed name and date: HMS OAKLEY 1941, which was not visible before. This is a very interesting discovery because all British ships that were handed over to the Polish Navy during WWII had their bells changed to that of the Polish names of the ships. There are no documents in the National Archives in Kew and the Polish Institute and Sikorski Museum in London which confirmed the bell with its original name onboard ORP Kujawiak. The iron clapper was found to still be in situ, while the iron suspension bracket bolts fastening this bracket to the bronze bell were loosened without any damage in order to be treated separately. The bell and its iron attachments have been cleaned and the process continues. Analysis of the metal composition of the bell will be undertaken at Heritage Malta's Diagnostic Scientific Laboratories. This will provide further information to conservators regarding the treatments to be undertaken. The bell will be gradually dried after desalination, further mechanical cleaning will be undertaken, and with the eventual stabilization of the different metal components the protective coatings will finally be applied. It will still be monitored to ensure that no further deterioration develops.

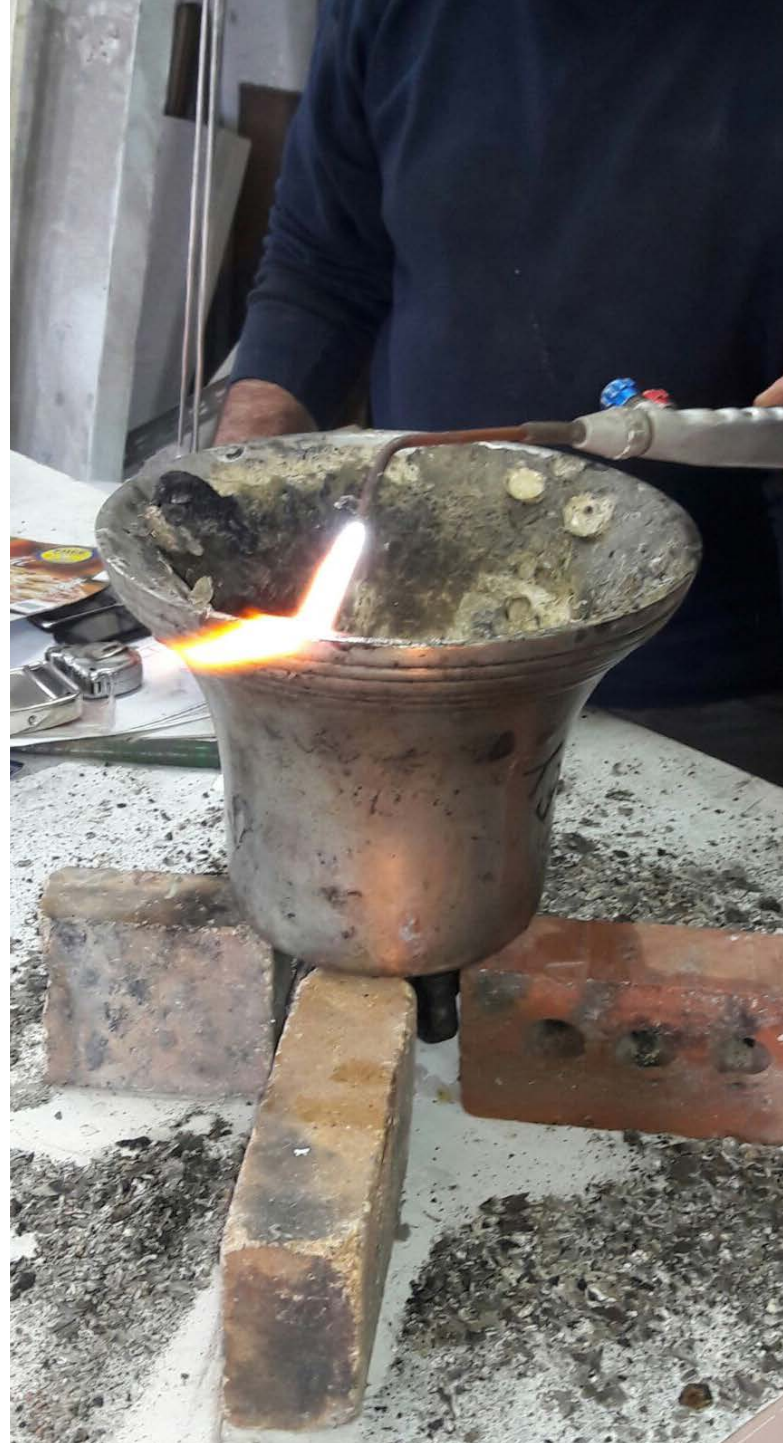
**Photo:** Removing the concretions from the inside. *(photo: Heritage Malta)*
